Access Compliance Report

Public Rights-of-Way

(Curb Ramps)

Intersection ID: 24093	Main Street: LIVINGSTON_MILL_RD	Cross Street: ROYALWOOD_LN	Location: NW
ADA ID: 255B98770D5C	Ramp Type: PerpDiag	Initial Pass/Fail: Fail	Overall Compliance: No
		Severity Score: 22.5

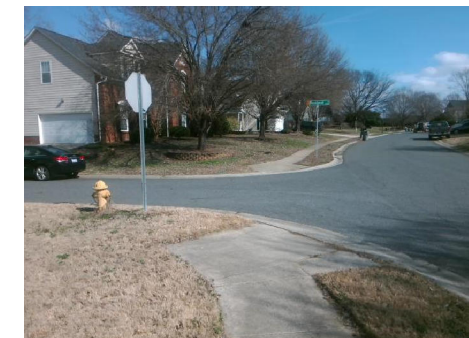
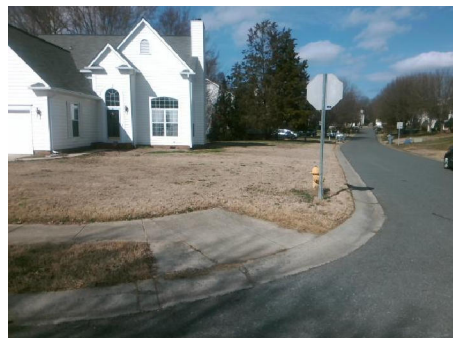
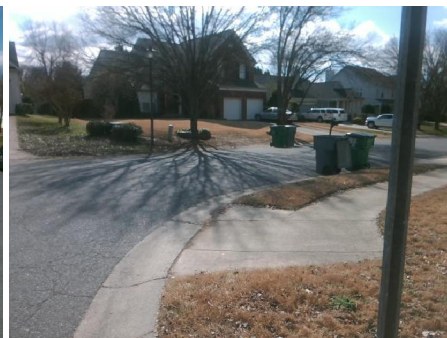
Compliance	Description	Data	Compliance	Description	Data
N/A	Ramp Length (in)	96.0	No	Ramp Slope (%)	8.8
No	Ramp Width (in)	47.0	No	Ramp XSlope (%)	3.9
N/A	Flare Type LT	N/A	N/A	Flare Type RT	N/A
N/A	Flare Slope LT (%)	N/A	N/A	Flare Slope RT (%)	N/A
N/A	Flare Traversable LT?	N/A	N/A	Flare Traversable RT?	N/A
N/A	Landing Length (in)	N/A	N/A	DWS Provided?	N/A
N/A	Landing Width (in)	N/A	N/A	DWS Contrast?	N/A
N/A	Landing Slope (%)	N/A	N/A	DWS Length (in)	N/A
N/A	Landing X Slope (%)	N/A	N/A	DWS Full Width?	N/A
N/A	Landing Curb? (Y/N)	N/A	N/A	DWS Offset (in)	N/A
N/A	Shared Landing?	N/A			
N/A	Gutter Ponding?	N/A	N/A	Gutter Slope (%)	N/A
N/A	Gutter Lip Ht (in)	N/A	N/A	Gutter X Slope (%)	N/A
N/A	Painted X Walk1?	No	N/A	Painted X Walk2?	No
	X Walk 1 Direction	To S		X Walk 2 Direction	To E
N/A	X Walk 1 Width (in)	N/A	N/A	X Walk 2 Width (in)	N/A
	X Walk 1 Slope (%)	4.0		X Walk 2 Slope (%)	4.0
	X Walk 1 X Slope (%)	1.9		X Walk 2 X Slope (%)	0.8

N/A	Ramp inside XWalk1?	N/A	N/A	Ramp inside XWalk2?	N/A
	Road Slope (%)	0.7	N/A	Clear Space?	N/A
	Road X Slope (%)	3.2	N/A	Clear Space to XWalk (in)	N/A
N/A	Any Obstructions?	N/A	N/A	Storm Grate/Utility Hazard?	N/A
	Obstruction Type			Storm Grate/Utility Type	
		N/A			N/A
			Yes	Surface Condition? (G/P)	Good

Possible Solutions:

Remove & Replace Curb Ramp With Two New Directional Ramps or Equivalent.
