# Access Compliance Report

## Public Rights-of-Way

### (Curb Ramps)

Intersection ID: 10942	Main Street: S_I-77_EXIT_10B_RA	Cross Street: W_5TH_ST	Location: E
ADA ID: 255BEC0EEB4D	Ramp Type: PerpDiag	Initial Pass/Fail: Fail	Overall Compliance: No
Severity Score: 8.75			
Codes/Mitigation Info/Possible Solution		Field Measurements/Component Compliance

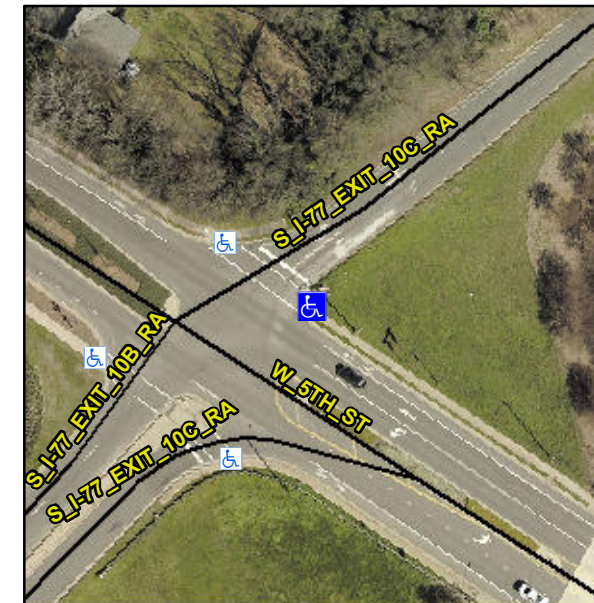
**Not Found, R304.5.1**

Compliance	Description	Data	Compliance	Description	Data
N/A	Ramp Length (in)	78.0	Yes	Ramp Slope (%)	5.2
No	Ramp Width (in)	47.5	Yes	Ramp XSlope (%)	0.8
N/A	Flare Type LT	N/A	N/A	Flare Type RT	N/A
N/A	Flare Slope LT (%)	N/A	N/A	Flare Slope RT (%)	N/A
N/A	Flare Traversable LT?	N/A	N/A	Flare Traversable RT?	N/A
N/A	Landing Length (in)	N/A	N/A	DWS Provided?	N/A
N/A	Landing Width (in)	N/A	N/A	DWS Contrast?	N/A
N/A	Landing Slope (%)	N/A	N/A	DWS Length (in)	N/A
N/A	Landing X Slope (%)	N/A	N/A	DWS Full Width?	N/A
N/A	Landing Curb? (Y/N)	N/A	N/A	DWS Offset (in)	N/A
N/A	Shared Landing?	N/A			
N/A	Gutter Ponding?	N/A	N/A	Gutter Slope (%)	N/A
N/A	Gutter Lip Ht (in)	0.5	N/A	Gutter X Slope (%)	N/A
N/A	Painted X Walk1?	Yes	N/A	Painted X Walk2?	No
	X Walk 1 Direction	To NW		X Walk 2 Direction	To SW
N/A	X Walk 1 Width (in)	110.0	N/A	X Walk 2 Width (in)	N/A
	X Walk 1 Slope (%)	3.6		X Walk 2 Slope (%)	4.3
	X Walk 1 X Slope (%)	2.1		X Walk 2 X Slope (%)	2.0

N/A	Ramp inside XWalk1?	Yes	N/A	Ramp inside XWalk2?	N/A
	Road Slope (%)	1.0	N/A	Clear Space?	N/A
	Road X Slope (%)	6.2	N/A	Clear Space to XWalk (in)	N/A
N/A	Any Obstructions?	N/A	N/A	Storm Grate/Utility Hazard?	N/A
	Obstruction Type			Storm Grate/Utility Type	
		N/A			N/A
		Yes		Surface Condition? (G/P)	Good

**Remove & Replace Curb Ramp With Two New Directional Ramps or Equivalent.**
