# Access Compliance Report

## Public Rights-of-Way

### (Curb Ramps)

| Intersection ID: 29281 | Main Street: IRON_BRIGADE_LN | Cross Street: TULLOCK_CREEK_DR | Location: W |

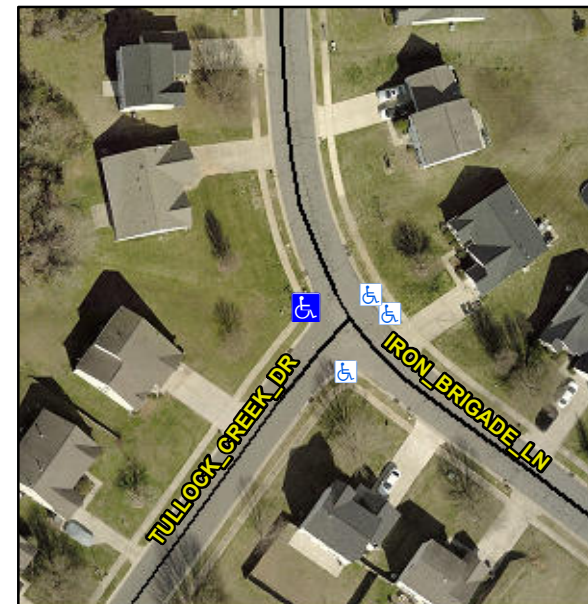
**DAMAGED CURB/GTR**

**Not Found, R304.5.1, R304.5.3**

| Compliance | Description | Data | Compliance | Description | Data |
|---|---|---|---|---|---|
| No | Ramp Width (in) | 46.0 | No | BlendTrans XSlope (%) | 4.1 |

**Remove & Replace Curb Ramp With Two New Directional Ramps or Equivalent.**
