Access Compliance Report

Public Rights-of-Way

(Curb Ramps)

| Intersection ID: 48092 | Main Street: HOLLAND_AV | Cross Street: STATESVILLE_AV | Location: SE |

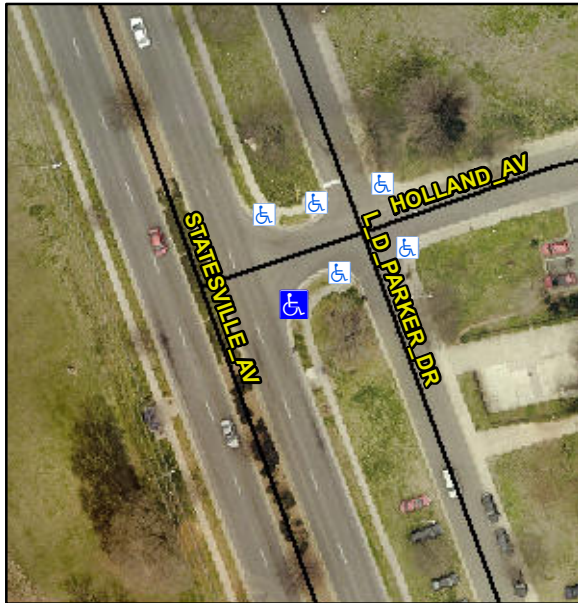
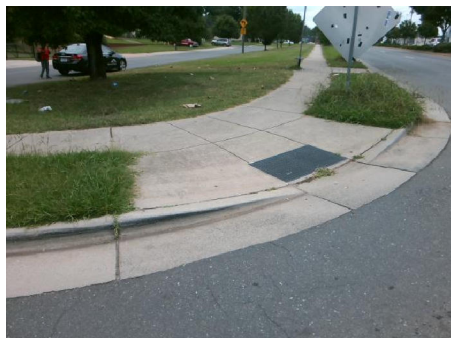
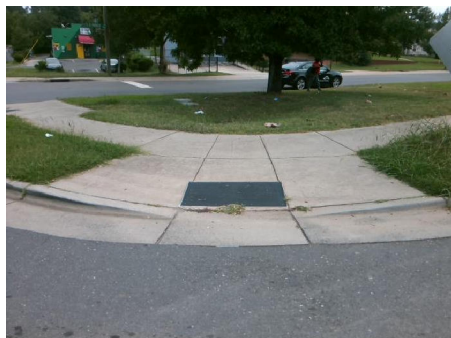
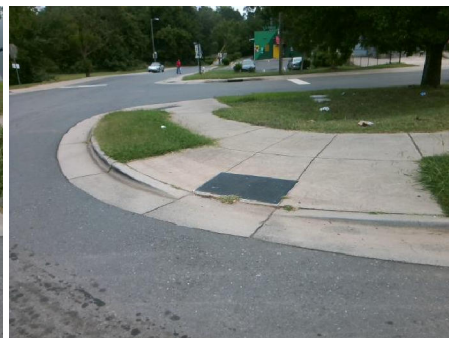
| ADA ID: 257A6166A9EE | Ramp Type: PerpDiag | Initial Pass/Fail: Fail | Overall Compliance: No |
| Severity Score: 22.5 | | | |

| Compliance | Description | Data | Compliance | Description | Data |
|---|---|---|---|---|---|
| N/A | Ramp Length (in) | 61.5 | No | Ramp Slope (%) | 8.4 |
| No | Ramp Width (in) | 38.0 | No | Ramp XSlope (%) | 5.0 |

Remove & Replace Curb Ramp With Two New Directional Ramps or Equivalent.
