# Access Compliance Report

## Public Rights-of-Way

### (Curb Ramps)

Intersection ID: 11176	Main Street: AVENSONG_CROSSING_DR	Cross Street: CELLO_CT	Location: SW
ADA ID: 257A6BE47C0A	Ramp Type: Combination1	Initial Pass/Fail: Fail	Overall Compliance: No
Codes/Mitigation Info/Possible Solution			Severity Score: 10
			Field Measurements/Component Compliance

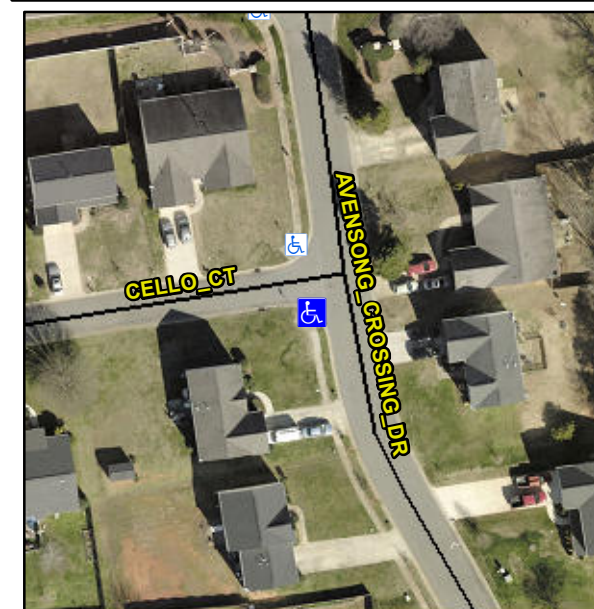
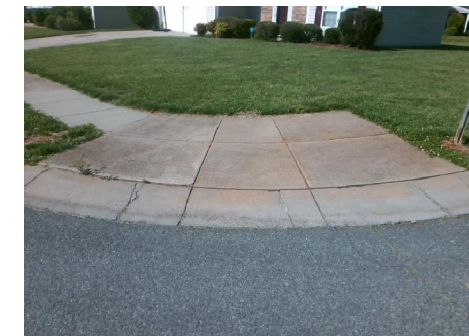
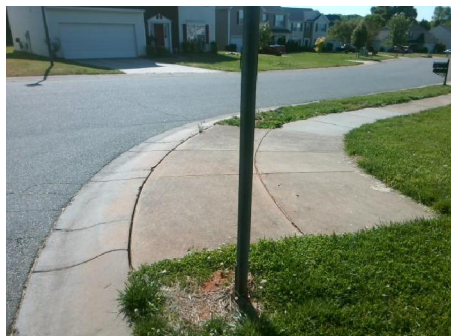
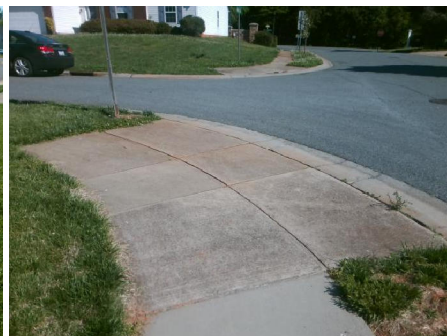
**CURB GAP 1.5**

**Not Found, R304.5.1, R304.5.1, R304.5.3**

Compliance	Description	Data	Compliance	Description	Data
N/A	Ramp Length LT (in)	44.0	N/A	Ramp Length RT (in)	52.5
No	Ramp Width LT (in)	47.5	Yes	Ramp Width RT (in)	48.0
Yes	Ramp Slope LT (%)	6.6	Yes	Ramp Slope RT (%)	5.7
Yes	Ramp XSlope LT (%)	1.6	No	Ramp XSlope RT (%)	2.5
N/A	Ramp Length (in)	48.0	Yes	Ramp Slope (%)	5.2
No	Ramp Width (in)	37.0	No	Ramp XSlope (%)	4.1
N/A	Flare Type LT	N/A	N/A	Flare Type RT	N/A
N/A	Flare Slope LT (%)	N/A	N/A	Flare Slope RT (%)	N/A
N/A	Flare Traversable LT?	N/A	N/A	Flare Traversable RT?	N/A
N/A	Landing Length (in)	N/A	N/A	DWS Provided?	N/A
N/A	Landing Width (in)	N/A	N/A	DWS Contrast?	N/A
N/A	Landing Slope (%)	N/A	N/A	DWS Length (in)	N/A
N/A	Landing X Slope (%)	N/A	N/A	DWS Full Width?	N/A
N/A	Landing Curb? (Y/N)	N/A	N/A	DWS Offset (in)	N/A
N/A	Shared Landing?	N/A			
N/A	Gutter Ponding?	N/A	N/A	Gutter Slope (%)	N/A
N/A	Gutter Lip Ht (in)	N/A	N/A	Gutter X Slope (%)	N/A
N/A	Painted X Walk1?	No	N/A	Painted X Walk2?	N/A

X Walk 1 Direction	To N		X Walk 2 Direction	N/A
	X Walk 1 Width (in)	N/A		X Walk 2 Width (in)	N/A
	X Walk 1 Slope (%)	3.4		X Walk 2 Slope (%)	N/A
	X Walk 1 X Slope (%)	0.1		X Walk 2 X Slope (%)	N/A
N/A	Ramp inside XWalk1?	N/A	N/A	Ramp inside XWalk2?	N/A
	Road Slope (%)	N/A		Clear Space?	N/A
	Road X Slope (%)	N/A	N/A	Clear Space to XWalk (in)	N/A
			N/A	Any Obstruction?	N/A
				Obstruction Type	N/A
			N/A	Storm Grate/Utility Hazard?	N/A
				Storm Grate/Utility Type	N/A
			Yes	Surface Condition? (G/P)	Good
				Curb Slope (%)	19.6

**Remove & Replace Entire Ramp.**
