# Access Compliance Report

## Public Rights-of-Way

### (Curb Ramps)

Intersection ID: 46932	Main Street: IDLEWILD_RD_NORTH	Cross Street: SYCAMORE_GROVE_CT	Location: SE
ADA ID: 258BC2554072	Ramp Type: PerpDiag	Initial Pass/Fail: Fail	Overall Compliance: No
Severity Score: 21.25			
Codes/Mitigation Info/Possible Solution		Field Measurements/Component Compliance

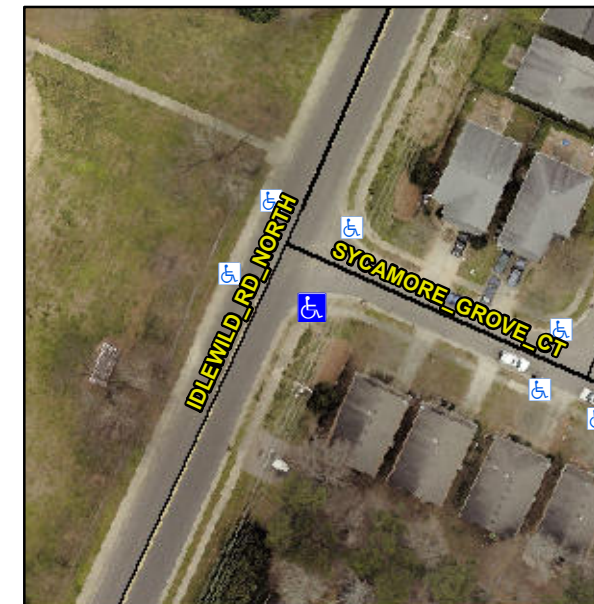
**Not Found, R304.5.1, R304.2.2**

Compliance	Description	Data	Compliance	Description	Data
N/A	Ramp Length (in)	47.5	No	Ramp Slope (%)	10.9
No	Ramp Width (in)	43.0	Yes	Ramp XSlope (%)	0.8
N/A	Flare Type LT	N/A	N/A	Flare Type RT	N/A
N/A	Flare Slope LT (%)	N/A	N/A	Flare Slope RT (%)	N/A
N/A	Flare Traversable LT?	N/A	N/A	Flare Traversable RT?	N/A
N/A	Landing Length (in)	N/A	N/A	DWS Provided?	N/A
N/A	Landing Width (in)	N/A	N/A	DWS Contrast?	N/A
N/A	Landing Slope (%)	N/A	N/A	DWS Length (in)	N/A
N/A	Landing X Slope (%)	N/A	N/A	DWS Full Width?	N/A
N/A	Landing Curb? (Y/N)	N/A	N/A	DWS Offset (in)	N/A
N/A	Shared Landing?	N/A			
N/A	Gutter Ponding?	N/A	N/A	Gutter Slope (%)	N/A
N/A	Gutter Lip Ht (in)	N/A	N/A	Gutter X Slope (%)	N/A
N/A	Painted X Walk1?	No	N/A	Painted X Walk2?	No
	X Walk 1 Direction	To NE		X Walk 2 Direction	To NW
N/A	X Walk 1 Width (in)	N/A	N/A	X Walk 2 Width (in)	N/A
	X Walk 1 Slope (%)	1.1		X Walk 2 Slope (%)	0.0
	X Walk 1 X Slope (%)	1.1		X Walk 2 X Slope (%)	0.0

N/A	Ramp inside XWalk1?	N/A	N/A	Ramp inside XWalk2?	N/A
	Road Slope (%)	1.3	N/A	Clear Space?	N/A
	Road X Slope (%)	0.1	N/A	Clear Space to XWalk (in)	N/A
N/A	Any Obstructions?	N/A	N/A	Storm Grate/Utility Hazard?	N/A
	Obstruction Type			Storm Grate/Utility Type	
		N/A			N/A
		Yes		Surface Condition? (G/P)	Good

**Remove & Replace Curb Ramp With Two New Directional Ramps or Equivalent.**

Total Cost: \$ 3200.00
