# Access Compliance Report

## Public Rights-of-Way

| Intersection ID: 48856 | Main Street: GREENFINCH_DR | Cross Street: NEELY_GLEN_DR | Location: NW |
| ADA ID: 2599CA3114D6 | Ramp Type: PerpDiag | Initial Pass/Fail: Fail | Overall Compliance: No |

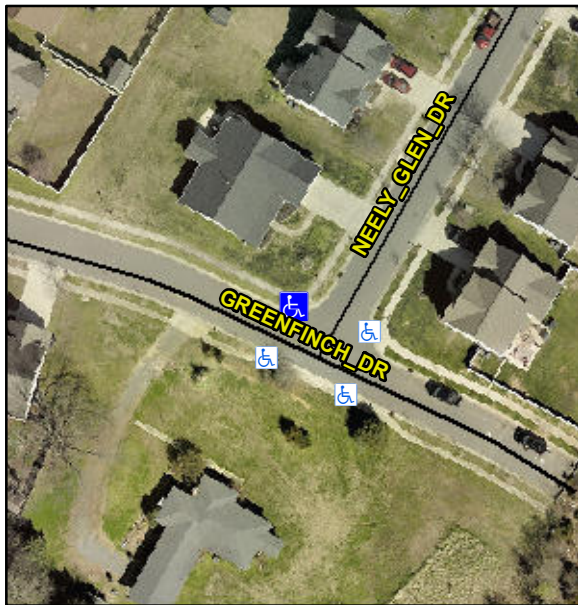
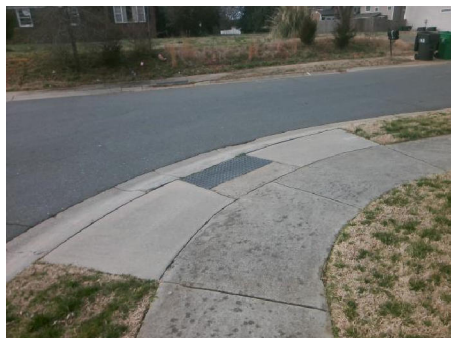
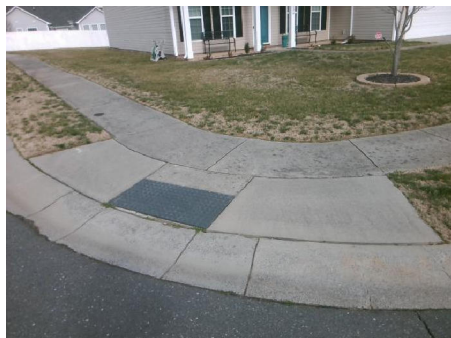
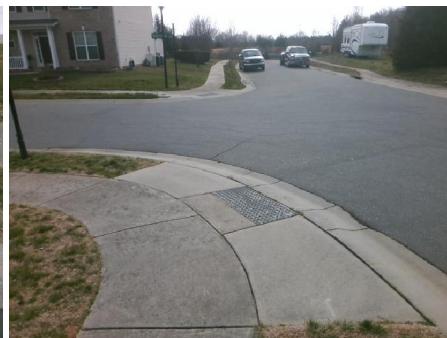
| | | Severity Score: 10 | |

**R304.5.1, R304.5.3**

| Compliance | Description | Data | Compliance | Description | Data |
|---|---|---|---|---|---|
| N/A | Ramp Length (in) | 43.5 | Yes | Ramp Slope (%) | 6.7 |
| No | Ramp Width (in) | 43.0 | No | Ramp XSlope (%) | 2.5 |

**Remove & Replace Curb Ramp With Two New Directional Ramps or Equivalent.**

Total Cost: \$ **3200.00**
