Intersection ID: 14441	Main Street: E_KINGSTON_AV	Cross Street: SPRINGDALE_AV	Location:	S
ADA ID: 25BDAF2877F7	Ramp Type: Perp	Initial Pass/Fail: Fail	Overall Compliance: No	Severity Score: 13.75

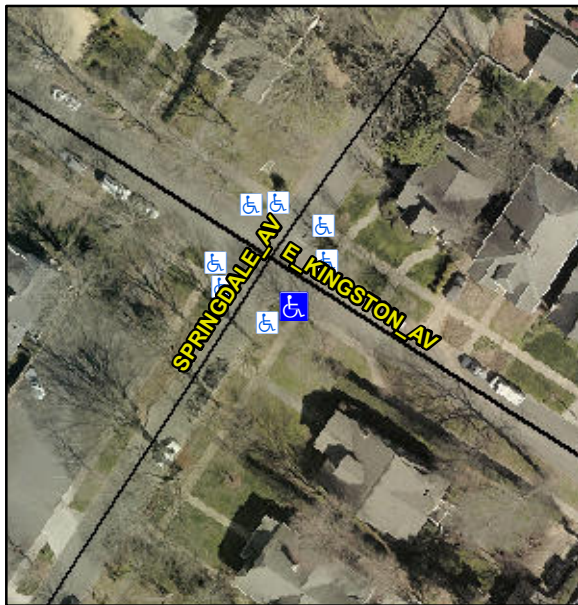
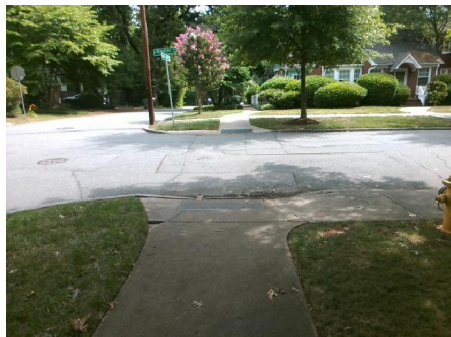
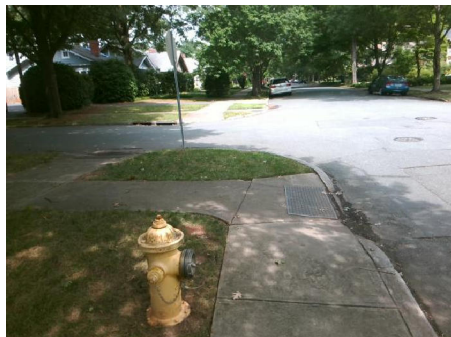
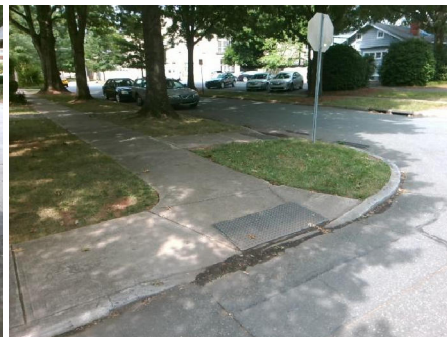
Not Found, R304.2.2, R304.5.3

Compliance	Description	Data	Compliance	Description	Data
N/A	Ramp Length (in)	65.0	No	Ramp Slope (%)	10.2
Yes	Ramp Width (in)	49.0	No	Ramp XSlope (%)	2.3
N/A	Flare Type LT	N/A	N/A	Flare Type RT	N/A
N/A	Flare Slope LT (%)	N/A	N/A	Flare Slope RT (%)	N/A
N/A	Flare Traversable LT?	N/A	N/A	Flare Traversable RT?	N/A
N/A	Landing Length (in)	N/A	N/A	DWS Provided?	N/A
N/A	Landing Width (in)	N/A	N/A	DWS Contrast?	N/A
N/A	Landing Slope (%)	N/A	N/A	DWS Length (in)	N/A
N/A	Landing X Slope (%)	N/A	N/A	DWS Full Width?	N/A
N/A	Landing Curb? (Y/N)	N/A	N/A	DWS Offset (in)	N/A
N/A	Shared Landing?	N/A			
N/A	Gutter Ponding?	Yes	N/A	Gutter Slope (%)	N/A
N/A	Gutter Lip Ht (in)	N/A	N/A	Gutter X Slope (%)	N/A
N/A	Painted X Walk1?	No	N/A	Painted X Walk2?	N/A
	X Walk 1 Direction	To NE		X Walk 2 Direction	N/A
N/A	X Walk 1 Width (in)	N/A	N/A	X Walk 2 Width (in)	N/A
	X Walk 1 Slope (%)	4.1		X Walk 2 Slope (%)	N/A
	X Walk 1 X Slope (%)	1.5		X Walk 2 X Slope (%)	N/A

N/A	Ramp inside XWalk1?	N/A	N/A	Ramp inside XWalk2?	N/A
	Road Slope (%)	N/A	N/A	Clear Space?	N/A
	Road X Slope (%)	N/A	N/A	Clear Space to XWalk (in)	N/A
N/A	Any Obstructions?	N/A	N/A	Storm Grate/Utility Hazard?	N/A
	Obstruction Type			Storm Grate/Utility Type	
		N/A			N/A
			Yes	Surface Condition? (G/P)	Good

Remove & Replace Entire Ramp.

Total Cost: \$ 1850.00
