# Access Compliance Report

## Public Rights-of-Way

### (Curb Ramps)

Intersection ID: 47910	Main Street: ROOK_RD	Cross Street: MOUNTAIN_QUAIL_DR	Location:	N
ADA ID: 25C6F4E69DD9	Ramp Type: PerpDiag	Initial Pass/Fail: Fail	Overall Compliance: No	Severity Score: 22.5
Codes/Mitigation Info/Possible Solution		Field Measurements/Component Compliance

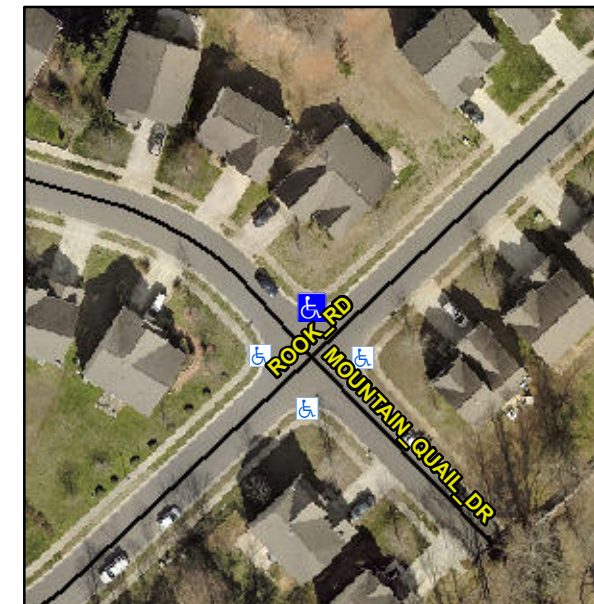
**Not Found, R304.5.1, R304.2.2, R304.5.3**

Compliance	Description	Data	Compliance	Description	Data
N/A	Ramp Length (in)	52.0	No	Ramp Slope (%)	8.5
No	Ramp Width (in)	40.0	No	Ramp XSlope (%)	3.5
N/A	Flare Type LT	N/A	N/A	Flare Type RT	N/A
N/A	Flare Slope LT (%)	N/A	N/A	Flare Slope RT (%)	N/A
N/A	Flare Traversable LT?	N/A	N/A	Flare Traversable RT?	N/A
N/A	Landing Length (in)	N/A	N/A	DWS Provided?	N/A
N/A	Landing Width (in)	N/A	N/A	DWS Contrast?	N/A
N/A	Landing Slope (%)	N/A	N/A	DWS Length (in)	N/A
N/A	Landing X Slope (%)	N/A	N/A	DWS Full Width?	N/A
N/A	Landing Curb? (Y/N)	N/A	N/A	DWS Offset (in)	N/A
N/A	Shared Landing?	N/A			
N/A	Gutter Ponding?	N/A	N/A	Gutter Slope (%)	N/A
N/A	Gutter Lip Ht (in)	N/A	N/A	Gutter X Slope (%)	N/A
N/A	Painted X Walk1?	No	N/A	Painted X Walk2?	No
	X Walk 1 Direction	To SW		X Walk 2 Direction	To SE
N/A	X Walk 1 Width (in)	N/A	N/A	X Walk 2 Width (in)	N/A
	X Walk 1 Slope (%)	0.3		X Walk 2 Slope (%)	3.7
	X Walk 1 X Slope (%)	3.3		X Walk 2 X Slope (%)	0.6

N/A	Ramp inside XWalk1?	N/A	N/A	Ramp inside XWalk2?	N/A
	Road Slope (%)	1.4	N/A	Clear Space?	N/A
	Road X Slope (%)	2.1	N/A	Clear Space to XWalk (in)	N/A
N/A	Any Obstructions?	N/A	N/A	Storm Grate/Utility Hazard?	N/A
	Obstruction Type			Storm Grate/Utility Type	
		N/A			N/A
			Yes	Surface Condition? (G/P)	Good

**Remove & Replace Curb Ramp With Two New Directional Ramps or Equivalent.**

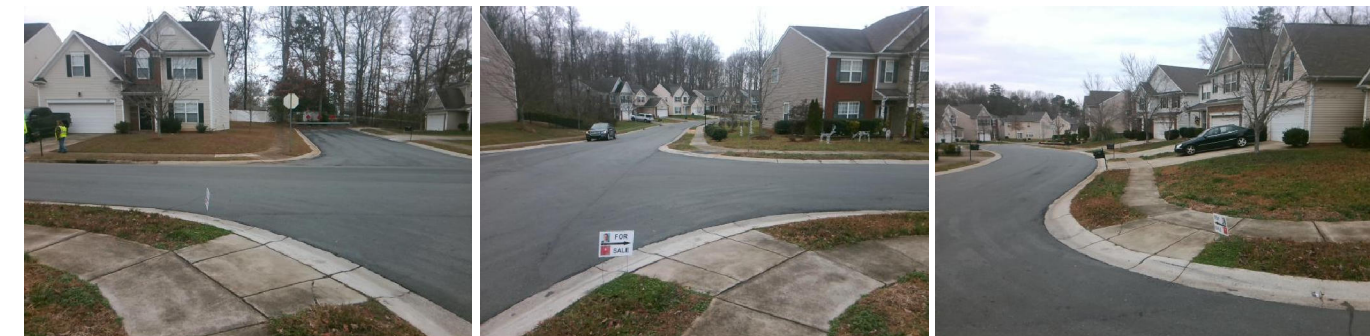
Street 1 Name MOUNTAIN QUAIL DR  
 Stop Condition-Street 2 StopSign  
 Street 2 Name ROOK RD  
 Stop Condition-Street 1 None
