Intersection ID: 45759	Main Street: LEONINE_CT	Cross Street: GRANDEUR_RD	Location:	W
ADA ID: 25C89AE3BE60	Ramp Type: Perp	Initial Pass/Fail: Fail	Overall Compliance: No	Severity Score: 12.5

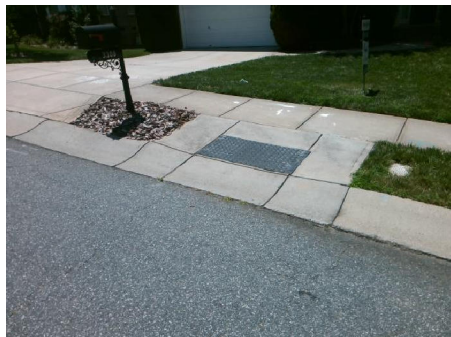
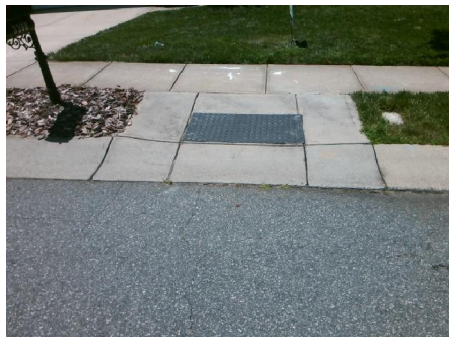
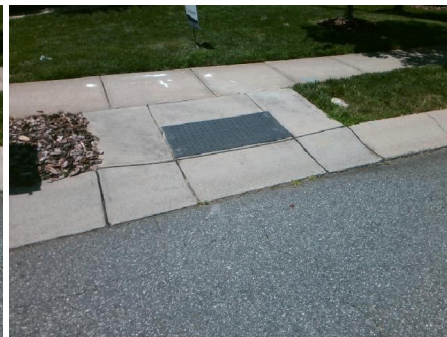
Not Found, R304.5.3

Compliance	Description	Data	Compliance	Description	Data
N/A	Ramp Length (in)	48.0	Yes	Ramp Slope (%)	7.8
Yes	Ramp Width (in)	48.0	No	Ramp XSlope (%)	6.7
N/A	Flare Type LT	N/A	N/A	Flare Type RT	N/A
N/A	Flare Slope LT (%)	N/A	N/A	Flare Slope RT (%)	N/A
N/A	Flare Traversable LT?	N/A	N/A	Flare Traversable RT?	N/A
N/A	Landing Length (in)	N/A	N/A	DWS Provided?	N/A
N/A	Landing Width (in)	N/A	N/A	DWS Contrast?	N/A
N/A	Landing Slope (%)	N/A	N/A	DWS Length (in)	N/A
N/A	Landing X Slope (%)	N/A	N/A	DWS Full Width?	N/A
N/A	Landing Curb? (Y/N)	N/A	N/A	DWS Offset (in)	N/A
N/A	Shared Landing?	N/A			
N/A	Gutter Ponding?	N/A	N/A	Gutter Slope (%)	N/A
N/A	Gutter Lip Ht (in)	N/A	N/A	Gutter X Slope (%)	N/A
N/A	Painted X Walk1?	No	N/A	Painted X Walk2?	N/A
	X Walk 1 Direction	To SE		X Walk 2 Direction	N/A
N/A	X Walk 1 Width (in)	N/A	N/A	X Walk 2 Width (in)	N/A
	X Walk 1 Slope (%)	4.5		X Walk 2 Slope (%)	N/A
	X Walk 1 X Slope (%)	6.6		X Walk 2 X Slope (%)	N/A

N/A	Ramp inside XWalk1?	N/A	N/A	Ramp inside XWalk2?	N/A
	Road Slope (%)	N/A	N/A	Clear Space?	N/A
	Road X Slope (%)	N/A	N/A	Clear Space to XWalk (in)	N/A
N/A	Any Obstructions?	N/A	N/A	Storm Grate/Utility Hazard?	N/A
	Obstruction Type			Storm Grate/Utility Type	
		N/A			N/A
			Yes	Surface Condition? (G/P)	Good

Remove & Replace Entire Ramp.
