# Access Compliance Report

## Public Rights-of-Way

### (Curb Ramps)

Intersection ID: 7186	Main Street: BEATTIES_FORD_RD	Cross Street: FAIRDALE_DR	Location: SW
ADA ID: 25D8F2A857F2	Ramp Type: PerpDiag	Initial Pass/Fail: Fail	Overall Compliance: No
Severity Score: 33.75			
Codes/Mitigation Info/Possible Solution		Field Measurements/Component Compliance

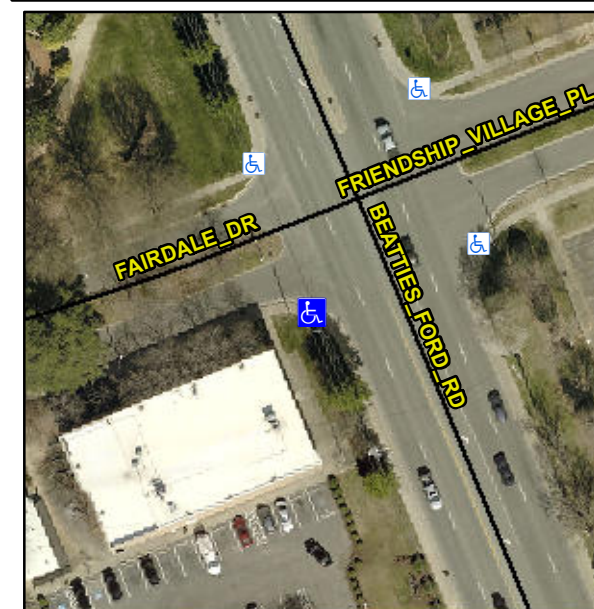
**Not Found, R304.5.1, R304.2.2**

Compliance	Description	Data	Compliance	Description	Data
N/A	Ramp Length (in)	59.5	No	Ramp Slope (%)	12.5
No	Ramp Width (in)	46.0	Yes	Ramp XSlope (%)	0.4
N/A	Flare Type LT	N/A	N/A	Flare Type RT	N/A
N/A	Flare Slope LT (%)	N/A	N/A	Flare Slope RT (%)	N/A
N/A	Flare Traversable LT?	N/A	N/A	Flare Traversable RT?	N/A
N/A	Landing Length (in)	N/A	N/A	DWS Provided?	N/A
N/A	Landing Width (in)	N/A	N/A	DWS Contrast?	N/A
N/A	Landing Slope (%)	N/A	N/A	DWS Length (in)	N/A
N/A	Landing X Slope (%)	N/A	N/A	DWS Full Width?	N/A
N/A	Landing Curb? (Y/N)	N/A	N/A	DWS Offset (in)	N/A
N/A	Shared Landing?	N/A			
N/A	Gutter Ponding?	N/A	N/A	Gutter Slope (%)	N/A
N/A	Gutter Lip Ht (in)	N/A	N/A	Gutter X Slope (%)	N/A
N/A	Painted X Walk1?	No	N/A	Painted X Walk2?	No
	X Walk 1 Direction	To NE		X Walk 2 Direction	To NW
N/A	X Walk 1 Width (in)	N/A	N/A	X Walk 2 Width (in)	N/A
	X Walk 1 Slope (%)	1.2		X Walk 2 Slope (%)	0.4
	X Walk 1 X Slope (%)	0.3		X Walk 2 X Slope (%)	0.2

N/A	Ramp inside XWalk1?	N/A	N/A	Ramp inside XWalk2?	N/A
	Road Slope (%)	0.9	N/A	Clear Space?	N/A
	Road X Slope (%)	0.2	N/A	Clear Space to XWalk (in)	N/A
N/A	Any Obstructions?	N/A	N/A	Storm Grate/Utility Hazard?	N/A
	Obstruction Type			Storm Grate/Utility Type	
		N/A			N/A
			Yes	Surface Condition? (G/P)	Good

**Remove & Replace Curb Ramp With Two New Directional Ramps or Equivalent.**
