Access Compliance Report

Public Rights-of-Way

(Curb Ramps)

| Intersection ID: 9360 | Main Street: BOONE_ST | Cross Street: OAKLAWN_AV | Location: NE |

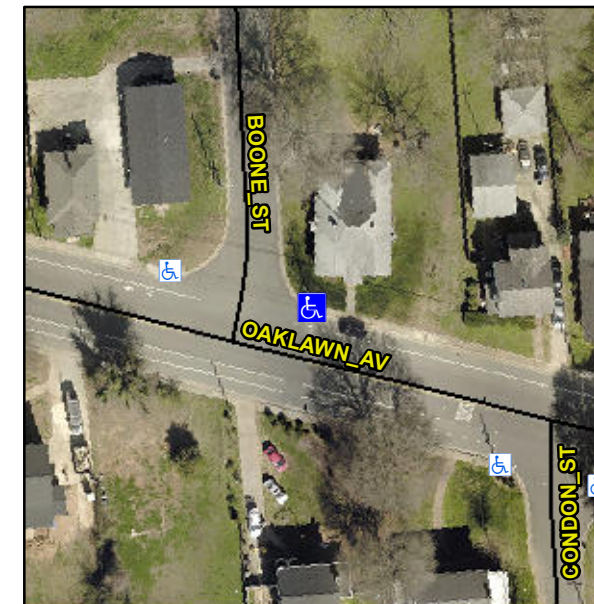
| ADA ID: 25DCB770048C | Ramp Type: Perp | Initial Pass/Fail: Fail | Overall Compliance: No |
| Severity Score: 22.5 | | | |

Not Found, R304.5.1, R304.2.2, R304.5.3

| Compliance | Description | Data | Compliance | Description | Data |
|---|---|---|---|---|---|
| N/A | Ramp Length (in) | 56.0 | No | Ramp Slope (%) | 10.0 |
| No | Ramp Width (in) | 47.0 | No | Ramp XSlope (%) | 2.8 |

Possible Solutions:

Remove & Replace Entire Ramp.

Total Cost: \$ 1850.00
