Access Compliance Report

Public Rights-of-Way

(Curb Ramps)

Intersection ID: 5966	Main Street: SUNSTONE_DR	Cross Street: STATESVILLE_RD	Location: SW
ADA ID: 25E54432C246	Ramp Type: Perp	Initial Pass/Fail: Fail	Overall Compliance: No
			Severity Score: 13.75

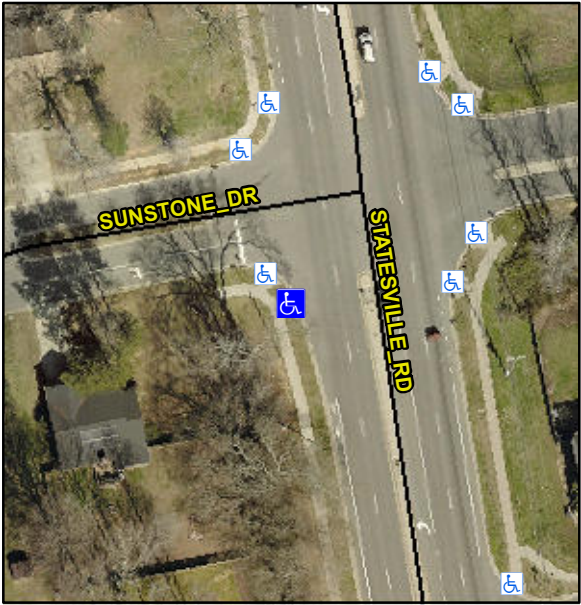
Possible Solutions:		Compliance	Description	Data
	Remove & Replace Entire Ramp.		No	Ramp Length (in)	96.0
			Yes	Ramp Width (in)	48.0
			N/A	Flare Type LT	N/A
			N/A	Flare Slope LT (%)	N/A
			N/A	Flare Traversable LT?	N/A
			N/A	Landing Length (in)	N/A
			N/A	Landing Width (in)	N/A
			N/A	Landing Slope (%)	N/A
			N/A	Landing X Slope (%)	N/A
<p>Surveyor Notes:</p> <p>N/A</p> <p>PROW/ADA:</p> <p>Not Found, R304.2.2, R304.5.3</p>			N/A	Flare Type RT	N/A
			N/A	Flare Slope RT (%)	N/A
			N/A	Flare Traversable RT?	N/A
			N/A	DWS Provided?	N/A
			N/A	DWS Contrast?	N/A
			N/A	DWS Length (in)	N/A
			N/A	DWS Full Width?	N/A
			N/A	DWS Offset (in)	N/A
			N/A	Gutter Ponding?	N/A
			N/A	Gutter Lip Ht (in)	N/A
			No	Painted X Walk1?	N/A
			To E	X Walk 1 Direction	N/A
			N/A	X Walk 1 Width (in)	N/A

1.8	X Walk 1 Slope (%)	N/A
			1.0	X Walk 1 X Slope (%)	N/A
			N/A	Ramp inside XWalk1?	N/A
			N/A	Road Slope (%)	N/A
			N/A	Road X Slope (%)	N/A
			N/A	Any Obstructions?	N/A
				Obstruction Type	N/A
Total Cost: \$ 1850.00			N/A	Storm Grate/Utility Hazard?	N/A
			N/A	Storm Grate/Utility Type	N/A
			Yes	Surface Condition? (G/P)	Good
