Access Compliance Report

Public Rights-of-Way

(Curb Ramps)

| Intersection ID: 2799 | Main Street: CARDINAL_POINT_RD | Cross Street: RED_ROSE_CT | Location: NW |

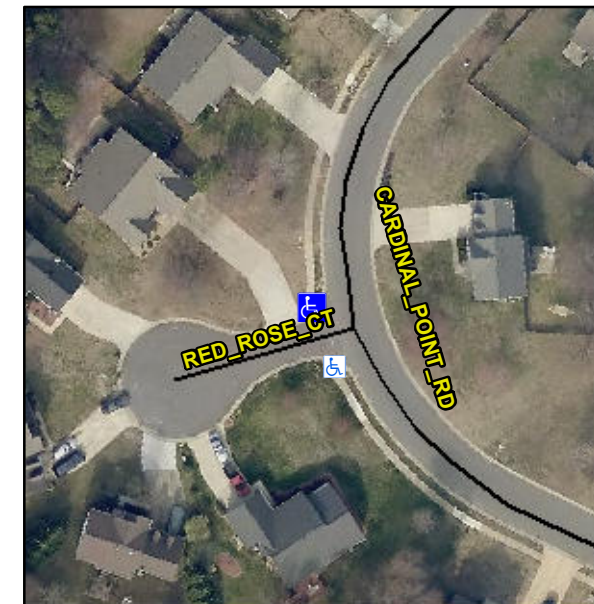
| ADA ID: 25E8288784F6 | Ramp Type: Perp | Initial Pass/Fail: Fail | Overall Compliance: No |
| Codes/Mitigation Info/Possible Solution | | | Severity Score: 25 |

R304.2.2, R304.5.3

| Compliance | Description | Data | Compliance | Description | Data |
|---|---|---|---|---|---|
| N/A | Ramp Length (in) | 52.0 | No | Ramp Slope (%) | 8.6 |
| Yes | Ramp Width (in) | 59.0 | No | Ramp XSlope (%) | 5.9 |

Possible Solutions:

Remove & Replace Entire Ramp.

Total Cost: \$ 1850.00
