# Access Compliance Report

## Public Rights-of-Way

Intersection ID: 29246	Main Street: LENSWOOD_CT	Cross Street: WOODINGTON_LN	Location: S
ADA ID: 25F886216FD0	Ramp Type: PerpDiag	Initial Pass/Fail: Fail	Overall Compliance: No
Codes/Mitigation Info/Possible Solution		Field Measurements/Component Compliance	
Severity Score: 35

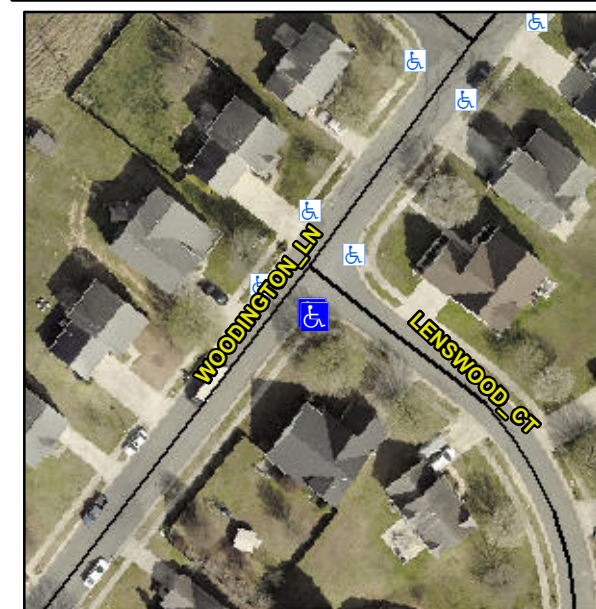
**Not Found, R304.5.1, R304.2.2, R304.5.3**

Compliance	Description	Data	Compliance	Description	Data
N/A	Ramp Length (in)	45.0	No	Ramp Slope (%)	13.5
No	Ramp Width (in)	43.0	No	Ramp XSlope (%)	2.1
N/A	Flare Type LT	N/A	N/A	Flare Type RT	N/A
N/A	Flare Slope LT (%)	N/A	N/A	Flare Slope RT (%)	N/A
N/A	Flare Traversable LT?	N/A	N/A	Flare Traversable RT?	N/A
N/A	Landing Length (in)	N/A	N/A	DWS Provided?	N/A
N/A	Landing Width (in)	N/A	N/A	DWS Contrast?	N/A
N/A	Landing Slope (%)	N/A	N/A	DWS Length (in)	N/A
N/A	Landing X Slope (%)	N/A	N/A	DWS Full Width?	N/A
N/A	Landing Curb? (Y/N)	N/A	N/A	DWS Offset (in)	N/A
N/A	Shared Landing?	N/A			
N/A	Gutter Ponding?	N/A	N/A	Gutter Slope (%)	N/A
N/A	Gutter Lip Ht (in)	N/A	N/A	Gutter X Slope (%)	N/A
N/A	Painted X Walk1?	No	N/A	Painted X Walk2?	No
	X Walk 1 Direction	To NE		X Walk 2 Direction	To NW
N/A	X Walk 1 Width (in)	N/A	N/A	X Walk 2 Width (in)	N/A
	X Walk 1 Slope (%)	1.5		X Walk 2 Slope (%)	1.0
	X Walk 1 X Slope (%)	2.8		X Walk 2 X Slope (%)	1.7

N/A	Ramp inside XWalk1?	N/A	N/A	Ramp inside XWalk2?	N/A
	Road Slope (%)	2.9	N/A	Clear Space?	N/A
	Road X Slope (%)	0.1	N/A	Clear Space to XWalk (in)	N/A
N/A	Any Obstructions?	N/A	N/A	Storm Grate/Utility Hazard?	N/A
	Obstruction Type			Storm Grate/Utility Type	
		N/A			N/A
			Yes	Surface Condition? (G/P)	Good

**Remove & Replace Curb Ramp With Two New Directional Ramps or Equivalent.**

Total Cost: \$ 3200.00
