## Access Compliance Report Public Rights-of-Way (Curb Ramps)

Intersection ID: N/A Main Street: WINDYGAP\_RD Cross Street: SELKIRKSHIRE\_RD Location: E

ADA ID: 25FC190C8D09 Ramp Type: Perp Initial Pass/Fail: Fail Overall Compliance: No Severity Score: 37.5

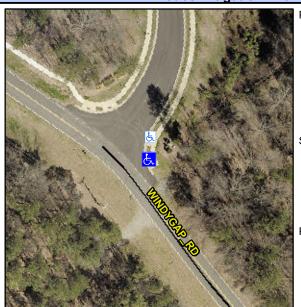
Field Measurements/Component Compliance								
Comp	liance Description	Data	Comp	liance Description	Data			
N/A	Ramp Length (in)	108.0	No	Ramp Slope (%)	8.4			
Yes	Ramp Width (in)	48.0	No	Ramp XSlope (%)	7.0			
N/A	Flare Type LT	N/A	N/A	Flare Type RT	N/A			
N/A	Flare Slope LT (%)	N/A	N/A	Flare Slope RT (%)	N/A			
N/A	Flare Traversable LT?	N/A	N/A	Flare Traversable RT?	N/A			
N/A	Landing Length (in)	N/A	N/A	DWS Provided?	N/A			
N/A	Landing Width (in)	N/A	N/A	DWS Contrast?	N/A			
N/A	Landing Slope (%)	N/A	N/A	DWS Length (in)	N/A			
N/A	Landing X Slope (%)	N/A	N/A	DWS Full Width?	N/A			
N/A	Landing Curb? (Y/N)	N/A	N/A	DWS Offset (in)	N/A			
N/A	Shared Landing?	N/A						
N/A	Gutter Ponding?	N/A	N/A	Gutter Slope (%)	N/A			
N/A	Gutter Lip Ht (in)	1.3	N/A	Gutter X Slope (%)	N/A			
N/A	Painted X Walk1?	No	N/A	Painted X Walk2?	N/A			
	X Walk 1 Direction	To SW		X Walk 2 Direction	N/A			
N/A	X Walk 1 Width (in)	N/A	N/A	X Walk 2 Width (in)	N/A

X Walk 1 Slope (%)	7.2		X Walk 2 Slope (%)	N/A			
	X Walk 1 X Slope (%)	4.4		X Walk 2 X Slope (%)	N/A			
N/A	Ramp inside XWalk1?	N/A	N/A	Ramp inside XWalk2?	N/A			
	Road Slope (%)	N/A	N/A	Clear Space?	N/A			
	Road X Slope (%)	N/A	N/A	Clear Space to XWalk (in)	N/A			
N/A	Any Obstructions?	N/A	N/A	Storm Grate/Utility Hazard?	N/A			
	Obstruction Type			Storm Grate/Utility Type				
		N/A			N/A			
			Yes	Surface Condition? (G/P)	Good			
	T 4.97

ğ	Possible Solutions:	,
と 一般を	Remove & Replace Entire Ramp.	
Designation of the second	Surveyor Notes: N/A	
THE RESERVE AND ADDRESS OF THE PARTY OF THE	PROW/ADA: Not Found, R304.2.2, R304.5.3
