Access Compliance Report

Public Rights-of-Way

| Intersection ID: 27056 | Main Street: PIPER_GLEN_DR | Cross Street: SANTORINI_LN | Location: NE |
| ADA ID: 2601DB0A22B3 | Ramp Type: Perp | Initial Pass/Fail: Fail | Overall Compliance: No |

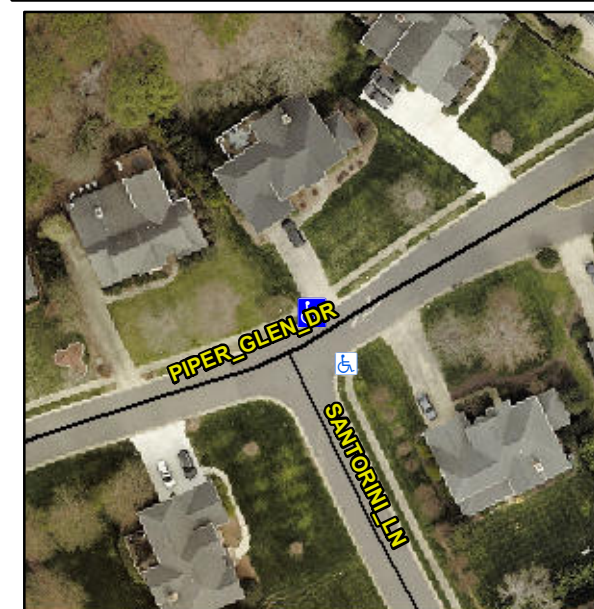
| Severity Score: 12.5 | | | |

R304.2.2

| Compliance | Description | Data | Compliance | Description | Data |
|---|---|---|---|---|---|
| N/A | Ramp Length (in) | 47.0 | No | Ramp Slope (%) | 8.7 |

Possible Solutions:

Remove & Replace Entire Ramp.

Total Cost:

\$ 1850.00
