# Access Compliance Report

## Public Rights-of-Way

### (Curb Ramps)

| Intersection ID: 50748 | Main Street: OPUS_LN | Cross Street: N/A | Location: | E |

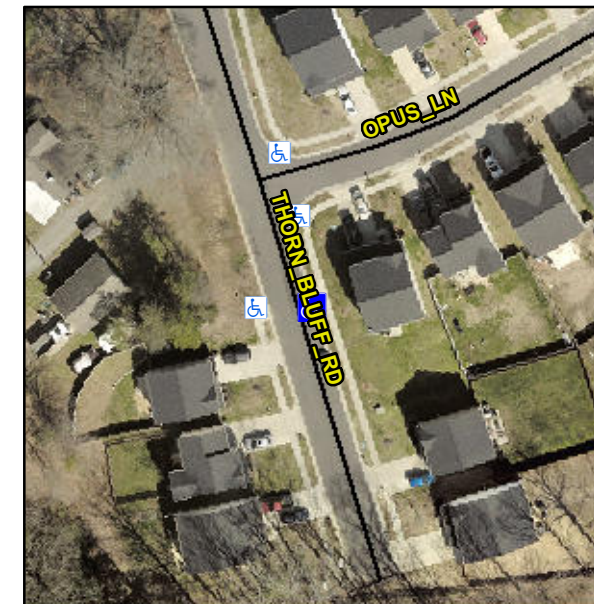
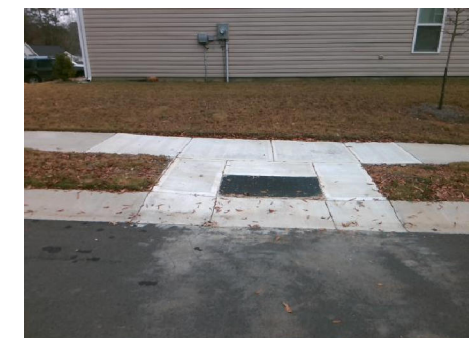
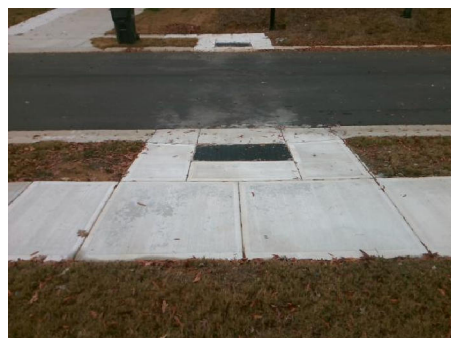
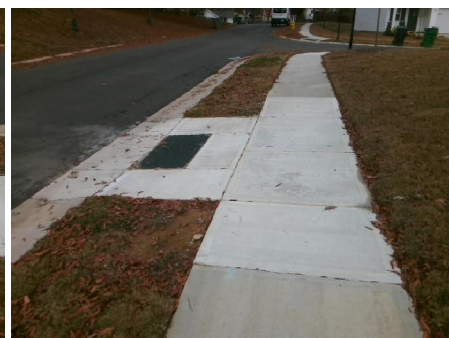
| ADA ID: 2607C8D081E8 | Ramp Type: Perp | Initial Pass/Fail: Fail | Overall Compliance: No | Severity Score: 22.5 |

**Not Found, R304.5.1, R304.2.2**

| Compliance | Description | Data | Compliance | Description | Data |
|---|---|---|---|---|---|
| N/A | Ramp Length (in) | 46.0 | No | Ramp Slope (%) | 8.9 |
| No | Ramp Width (in) | 47.0 | Yes | Ramp XSlope (%) | 2.2 |

**Remove & Replace Entire Ramp.**
