Access Compliance Report

Public Rights-of-Way

(Curb Ramps)

Intersection ID: N/A	Main Street: OLD_CONCORD_RD	Cross Street: ORCHID_BRIDGE_RD	Location: SW
ADA ID: 2623ADFF2D4F	Ramp Type: Perp	Initial Pass/Fail: Fail	Overall Compliance: No
Codes/Mitigation Info/Possible Solution		Field Measurements/Component Compliance	
Severity Score: 1.25

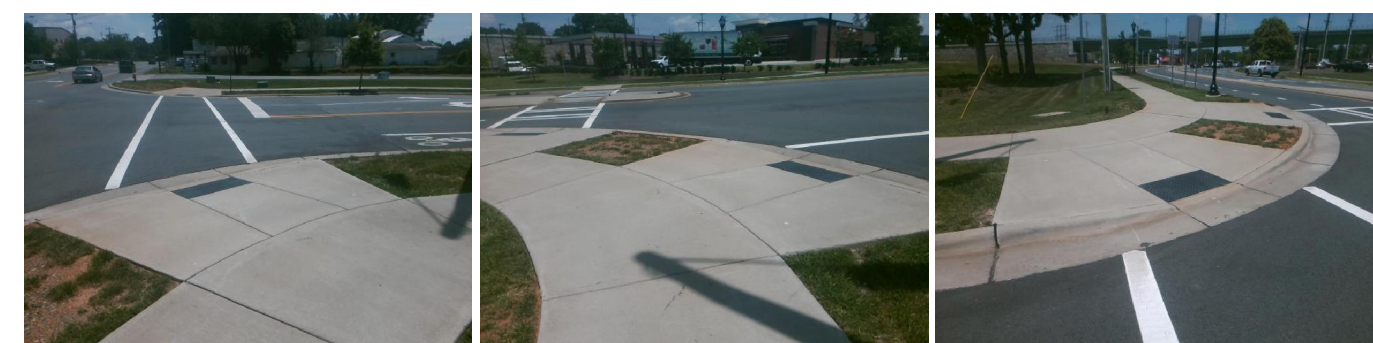
Possible Solutions:						
	Remove & Replace Entire Ramp.						
	Surveyor Notes:						
	N/A						
	PROW/ADA:						
	R304.5.3						
	Street 1 Name	ORCHID BRIDGE RD					
	Stop Condition-Street 2	StopSign					
	Street 2 Name	N/A					
	Stop Condition-Street 1	N/A					
Total Cost:		\$ 1850.00					
				Compliance	Description	Data	Compliance
				Description			Description
				Data			Data
				N/A	Ramp Length (in)	97.0	Yes
				Yes	Ramp Width (in)	48.0	No
				N/A	Flare Type LT	N/A	N/A
				N/A	Flare Slope LT (%)	N/A	N/A
				N/A	Flare Traversable LT?	N/A	N/A
				N/A	Landing Length (in)	N/A	N/A
				N/A	Landing Width (in)	N/A	N/A
				N/A	Landing Slope (%)	N/A	N/A
				N/A	Landing X Slope (%)	N/A	N/A
				N/A	Landing Curb? (Y/N)	N/A	N/A
				N/A	Shared Landing?	N/A	
				N/A	Gutter Ponding?	N/A	N/A
				N/A	Gutter Lip Ht (in)	N/A	N/A
				N/A	Painted X Walk1?	Yes	N/A
					X Walk 1 Direction	To E	
				N/A	X Walk 1 Width (in)	94.0	N/A
					X Walk 1 Slope (%)	1.0

X Walk 1 X Slope (%)	3.6	
				N/A	Ramp inside XWalk1?	Yes	N/A
					Road Slope (%)	N/A	N/A
					Road X Slope (%)	N/A	N/A
				N/A	Any Obstructions?	N/A	N/A
					Obstruction Type		
						N/A	N/A
				Yes	Surface Condition? (G/P)		Good
