# Access Compliance Report

## Public Rights-of-Way

### (Curb Ramps)

Intersection ID: 25747	Main Street: HAMILTON_RD	Cross Street: SMITH_RD	Location: NW
ADA ID: 2630F18D48EE	Ramp Type: Perp	Initial Pass/Fail: Fail	Overall Compliance: No
Severity Score: 25			
Codes/Mitigation Info/Possible Solution		Field Measurements/Component Compliance

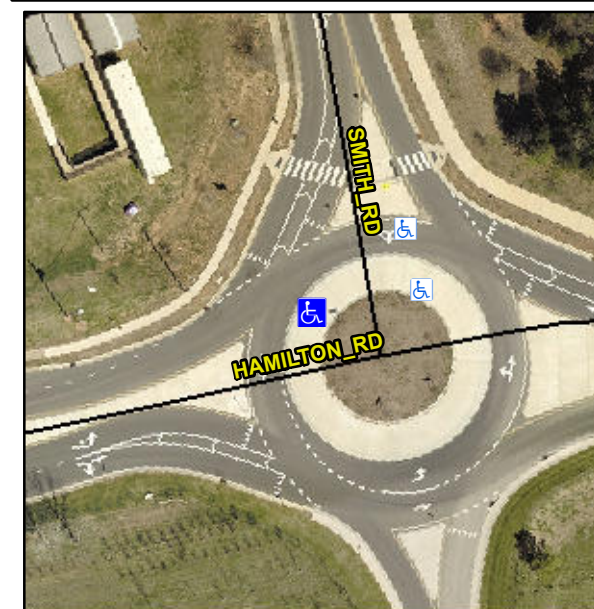
Compliance	Description	Data	Compliance	Description	Data
N/A	Ramp Length (in)	96.0	Yes	Ramp Slope (%)	6.0
Yes	Ramp Width (in)	60.0	No	Ramp XSlope (%)	8.5
N/A	Flare Type LT	N/A	N/A	Flare Type RT	N/A
N/A	Flare Slope LT (%)	N/A	N/A	Flare Slope RT (%)	N/A
N/A	Flare Traversable LT?	N/A	N/A	Flare Traversable RT?	N/A
N/A	Landing Length (in)	N/A	N/A	DWS Provided?	N/A
N/A	Landing Width (in)	N/A	N/A	DWS Contrast?	N/A
N/A	Landing Slope (%)	N/A	N/A	DWS Length (in)	N/A
N/A	Landing X Slope (%)	N/A	N/A	DWS Full Width?	N/A
N/A	Landing Curb? (Y/N)	N/A	N/A	DWS Offset (in)	N/A
N/A	Shared Landing?	N/A			
N/A	Gutter Ponding?	N/A	N/A	Gutter Slope (%)	N/A
N/A	Gutter Lip Ht (in)	N/A	N/A	Gutter X Slope (%)	N/A
N/A	Painted X Walk1?	Yes	N/A	Painted X Walk2?	N/A
	X Walk 1 Direction	To SE		X Walk 2 Direction	N/A
N/A	X Walk 1 Width (in)	120.0	N/A	X Walk 2 Width (in)	N/A
	X Walk 1 Slope (%)	1.7		X Walk 2 Slope (%)	N/A
	X Walk 1 X Slope (%)	4.6		X Walk 2 X Slope (%)	N/A

N/A	Ramp inside XWalk1?	Yes	N/A	Ramp inside XWalk2?	N/A
	Road Slope (%)	N/A	N/A	Clear Space?	N/A
	Road X Slope (%)	N/A	N/A	Clear Space to XWalk (in)	N/A
N/A	Any Obstructions?	N/A	N/A	Storm Grate/Utility Hazard?	N/A
	Obstruction Type			Storm Grate/Utility Type	
		N/A			N/A
			Yes	Surface Condition? (G/P)	Good

Possible Solutions:

**Remove & Replace Entire Ramp.**

**R304.5.3**

**\$ 1850.00**
