Access Compliance Report

Public Rights-of-Way

(Curb Ramps)

Intersection ID: 28863	Main Street: HAMPTON_PLACE_DR	Cross Street: DELAMERE_LN	Location: W
ADA ID: 263142B8F5AB	Ramp Type: PerpDiag	Initial Pass/Fail: Fail	Overall Compliance: No
Severity Score: 12.5			
Codes/Mitigation Info/Possible Solution		Field Measurements/Component Compliance

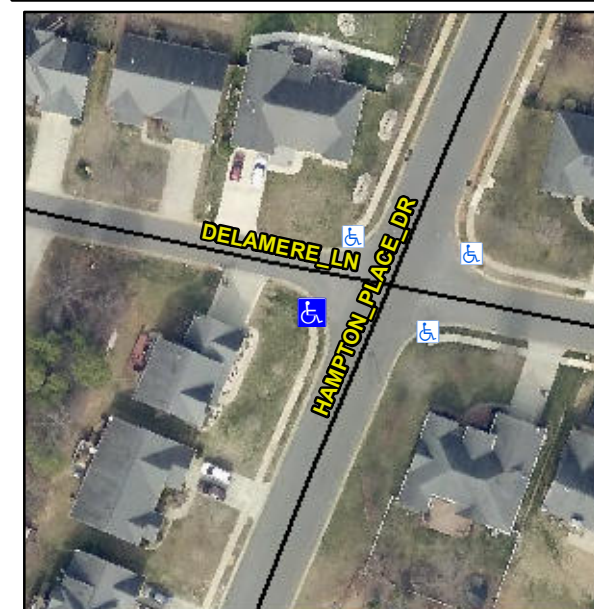
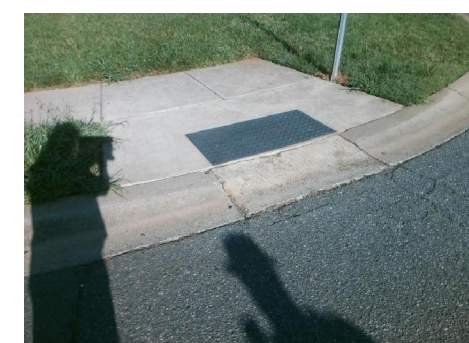
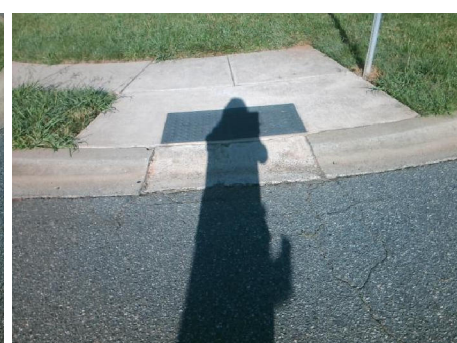
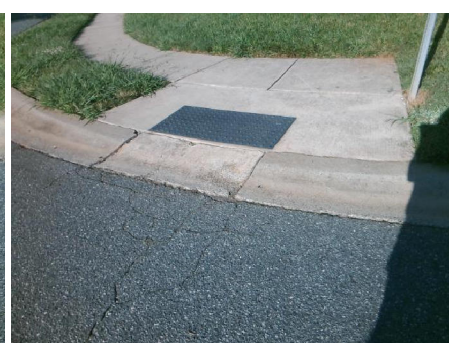
Compliance	Description	Data	Compliance	Description	Data
N/A	Ramp Length (in)	48.0	Yes	Ramp Slope (%)	5.0
Yes	Ramp Width (in)	48.0	No	Ramp XSlope (%)	5.7
N/A	Flare Type LT	N/A	N/A	Flare Type RT	N/A
N/A	Flare Slope LT (%)	N/A	N/A	Flare Slope RT (%)	N/A
N/A	Flare Traversable LT?	N/A	N/A	Flare Traversable RT?	N/A
N/A	Landing Length (in)	N/A	N/A	DWS Provided?	N/A
N/A	Landing Width (in)	N/A	N/A	DWS Contrast?	N/A
N/A	Landing Slope (%)	N/A	N/A	DWS Length (in)	N/A
N/A	Landing X Slope (%)	N/A	N/A	DWS Full Width?	N/A
N/A	Landing Curb? (Y/N)	N/A	N/A	DWS Offset (in)	N/A
N/A	Shared Landing?	N/A			
N/A	Gutter Ponding?	N/A	N/A	Gutter Slope (%)	N/A
N/A	Gutter Lip Ht (in)	N/A	N/A	Gutter X Slope (%)	N/A
N/A	Painted X Walk1?	No	N/A	Painted X Walk2?	No
	X Walk 1 Direction	To SE		X Walk 2 Direction	To NE
N/A	X Walk 1 Width (in)	N/A	N/A	X Walk 2 Width (in)	N/A
	X Walk 1 Slope (%)	2.0		X Walk 2 Slope (%)	6.2
	X Walk 1 X Slope (%)	5.5		X Walk 2 X Slope (%)	1.4

N/A	Ramp inside XWalk1?	N/A	N/A	Ramp inside XWalk2?	N/A
	Road Slope (%)	4.0	N/A	Clear Space?	N/A
	Road X Slope (%)	3.4	N/A	Clear Space to XWalk (in)	N/A
N/A	Any Obstructions?	N/A	N/A	Storm Grate/Utility Hazard?	N/A
	Obstruction Type			Storm Grate/Utility Type	
		N/A			N/A
		Yes		Surface Condition? (G/P)	Good

Possible Solutions:

Remove & Replace Curb Ramp With Two New Directional Ramps or Equivalent.
