Access Compliance Report

Public Rights-of-Way

(Curb Ramps)

Intersection ID: 52627	Main Street: PICASSO TERRACE LN	Cross Street: CORMWELL LN	Location: NW
ADA ID: 263AB2031A78	Ramp Type: Perp	Initial Pass/Fail: Fail	Overall Compliance: No
		Severity Score: 12.5

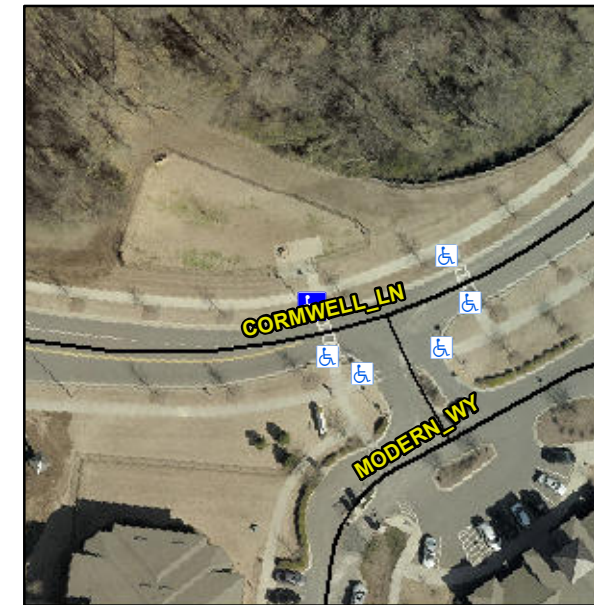
Not Found, R304.2.2

Compliance	Description	Data	Compliance	Description	Data
N/A	Ramp Length (in)	92.0	No	Ramp Slope (%)	8.4
Yes	Ramp Width (in)	58.0	Yes	Ramp XSlope (%)	0.6
N/A	Flare Type LT	N/A	N/A	Flare Type RT	N/A
N/A	Flare Slope LT (%)	N/A	N/A	Flare Slope RT (%)	N/A
N/A	Flare Traversable LT?	N/A	N/A	Flare Traversable RT?	N/A
N/A	Landing Length (in)	N/A	N/A	DWS Provided?	N/A
N/A	Landing Width (in)	N/A	N/A	DWS Contrast?	N/A
N/A	Landing Slope (%)	N/A	N/A	DWS Length (in)	N/A
N/A	Landing X Slope (%)	N/A	N/A	DWS Full Width?	N/A
N/A	Landing Curb? (Y/N)	N/A	N/A	DWS Offset (in)	N/A
N/A	Shared Landing?	N/A			
N/A	Gutter Ponding?	N/A	N/A	Gutter Slope (%)	N/A
N/A	Gutter Lip Ht (in)	N/A	N/A	Gutter X Slope (%)	N/A
N/A	Painted X Walk1?	Yes	N/A	Painted X Walk2?	N/A
	X Walk 1 Direction	To S		X Walk 2 Direction	N/A
N/A	X Walk 1 Width (in)	61.0	N/A	X Walk 2 Width (in)	N/A
	X Walk 1 Slope (%)	1.0		X Walk 2 Slope (%)	N/A
	X Walk 1 X Slope (%)	1.5		X Walk 2 X Slope (%)	N/A

N/A	Ramp inside XWalk1?	Yes	N/A	Ramp inside XWalk2?	N/A
	Road Slope (%)	N/A	N/A	Clear Space?	N/A
	Road X Slope (%)	N/A	N/A	Clear Space to XWalk (in)	N/A
N/A	Any Obstructions?	N/A	N/A	Storm Grate/Utility Hazard?	N/A
	Obstruction Type			Storm Grate/Utility Type	
		N/A			N/A
			Yes	Surface Condition? (G/P)	Good

Possible Solutions:

Remove & Replace Entire Ramp.
