# Access Compliance Report

## Public Rights-of-Way

### (Curb Ramps)

| Intersection ID: N/A | Main Street: 3RD_ST | Cross Street: CHARLOTTETOWNE_AV | Location: SW |

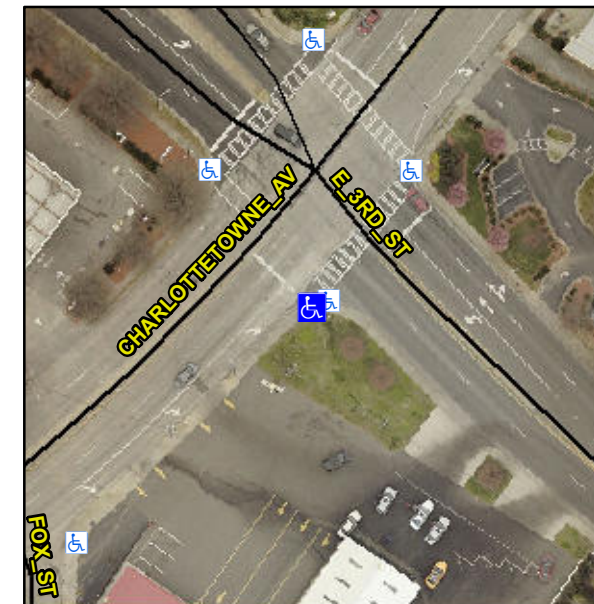
| ADA ID: 2645B0FB2883 | Ramp Type: Perp | Initial Pass/Fail: Fail | Overall Compliance: No |
| Severity Score: 46.25 | | | |

**R304.5.1, R304.2.2, R304.5.3**

| Compliance | Description | Data | Compliance | Description | Data |
|---|---|---|---|---|---|
| N/A | Ramp Length (in) | 60.5 | No | Ramp Slope (%) | 14.4 |
| No | Ramp Width (in) | 42.0 | No | Ramp XSlope (%) | 5.4 |

**Remove & Replace Entire Ramp.**

Total Cost: \$ 1850.00

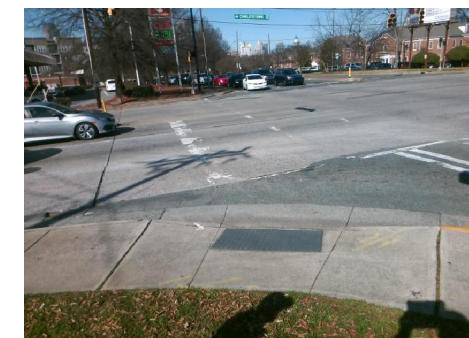
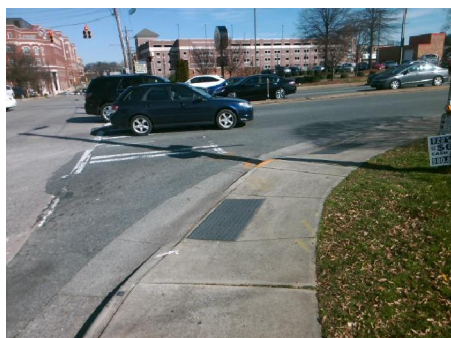
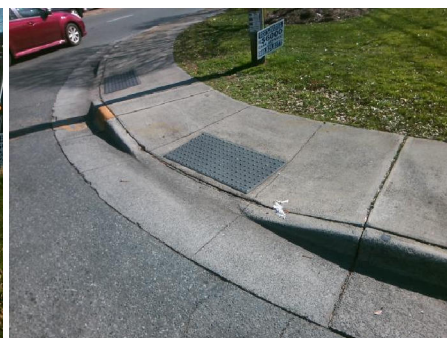
| Compliance | Description | Data | Compliance | Description | Data |
|---|---|---|---|---|---|
| | | | Yes | Surface Condition? (G/P) | Good |
