Access Compliance Report

Public Rights-of-Way

(Curb Ramps)

Intersection ID: 8636	Main Street: HATERAS_AV	Cross Street: KENNESAW_DR	Location: SW
ADA ID: 264C2AA73CB3	Ramp Type: PerpDiag	Initial Pass/Fail: Fail	Overall Compliance: No
		Severity Score: 12.5

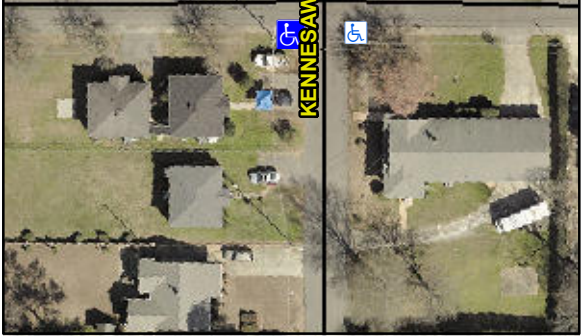
Surveyor Notes:		N/A	Ramp Length (in)	38.0
	N/A		Yes	Ramp Width (in)	81.0

Possible Solutions:		Compliance	Description	Data
	Remove & Replace Curb Ramp With Two New Directional Ramps or Equivalent.		Compliance	Description	Data
