Access Compliance Report

Public Rights-of-Way

(Curb Ramps)

Intersection ID: 5563	Main Street: N I-77 EXIT 16 RA	Cross Street: REAMES_RD	Location: SE
ADA ID: 26510B1DBAB1	Ramp Type: Directional1	Initial Pass/Fail: Pass	Overall Compliance: No
Codes/Mitigation Info/Possible Solution		Field Measurements/Component Compliance	
Severity Score: 0.25

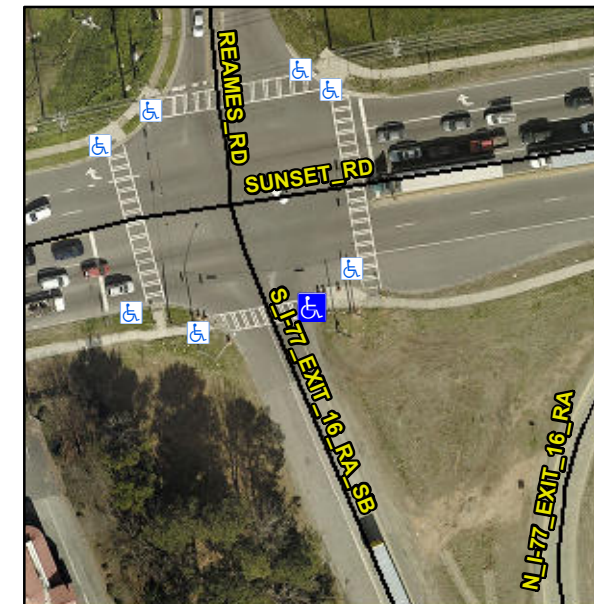
NO CURB

R304.5.3, R304.2.2-Perp, R304.3.2-Para

Compliance	Description	Data	Compliance	Description	Data
N/A	Ramp Length (in)	108.0	N/A	Grade Break?	N/A
Yes	Ramp Width (in)	72.0	N/A	Grade Break Slope (%)	0.0
Yes	Ramp Slope (%)	1.9	N/A	Grade Break XSlope (%)	0.0
No	Ramp XSlope (%)	2.2			
N/A	Flare Type LT	N/A	N/A	Flare Type RT	N/A
N/A	Flare Slope LT (%)	N/A	N/A	Flare Slope RT (%)	N/A
N/A	Flare Traversable LT?	N/A	N/A	Flare Traversable RT?	N/A
Yes	Landing Length (in)	72.0	Yes	DWS Provided?	Yes
Yes	Landing Width (in)	72.0	Yes	DWS Contrast?	Yes
No	Landing Slope (%)	2.5	Yes	DWS Length (in)	24.0
Yes	Landing X Slope (%)	1.6	Yes	DWS Full Width?	Yes
N/A	Landing Curb? (Y/N)	No	Yes	DWS Offset LT (in)	2.0
N/A	Shared Landing?	No	Yes	DWS Offset RT (in)	19.5
Yes	Gutter Ponding?	No	Yes	Gutter Slope (%)	2.2
Yes	Gutter Lip Ht (in)	0.0	No	Gutter X Slope (%)	4.9
N/A	Painted X Walk1?	No		Road Slope (%)	3.8
	X Walk 1 Direction	To W		Road X Slope (%)	1.3
	X Walk 1 Width (in)	N/A		Clear Space?	Yes

X Walk 1 Slope (%)	3.8	N/A	Clear Space to XWalk (in)	N/A
	X Walk 1 X Slope (%)	1.3	Yes	Storm Grate/Utility Hazard?	No
N/A	Ramp inside XWalk1?	N/A		Storm Grate/Utility Type	
Yes	Any Obstructions?	No			N/A
	Obstruction Type		Yes	Surface Condition? (G/P)	Good
			N/A	Curb Slope (%)	N/A

Possible Solutions:

**Remove & Replace Entire Ramp.
Remove & Replace Gutter.**
