# Access Compliance Report

## Public Rights-of-Way

### (Curb Ramps)

Intersection ID: N/A	Main Street: HUNTING BIRDS LN	Cross Street: LONG TALON WY	Location: NW
ADA ID: 2653104627DE	Ramp Type: PerpDiag	Initial Pass/Fail: Fail	Overall Compliance: No
		Severity Score: 10

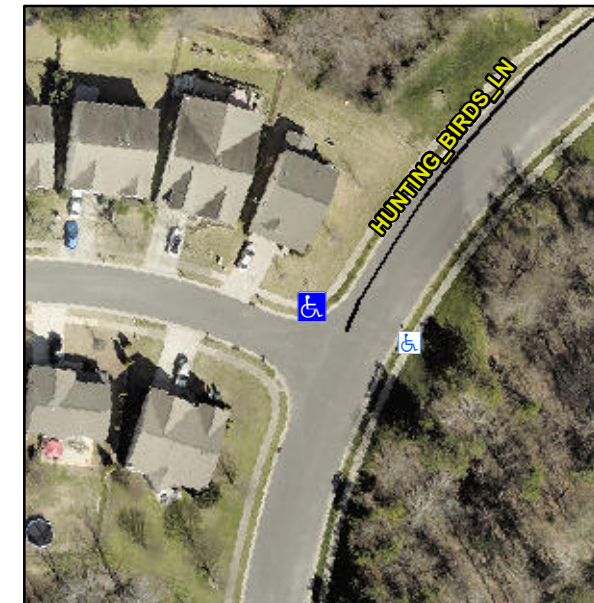
**Not Found, R304.5.1, R304.5.3**

Compliance	Description	Data	Compliance	Description	Data
N/A	Ramp Length (in)	47.0	Yes	Ramp Slope (%)	5.4
No	Ramp Width (in)	44.0	No	Ramp XSlope (%)	3.0
N/A	Flare Type LT	N/A	N/A	Flare Type RT	N/A
N/A	Flare Slope LT (%)	N/A	N/A	Flare Slope RT (%)	N/A
N/A	Flare Traversable LT?	N/A	N/A	Flare Traversable RT?	N/A
N/A	Landing Length (in)	N/A	N/A	DWS Provided?	N/A
N/A	Landing Width (in)	N/A	N/A	DWS Contrast?	N/A
N/A	Landing Slope (%)	N/A	N/A	DWS Length (in)	N/A
N/A	Landing X Slope (%)	N/A	N/A	DWS Full Width?	N/A
N/A	Landing Curb? (Y/N)	N/A	N/A	DWS Offset (in)	N/A
N/A	Shared Landing?	N/A			
N/A	Gutter Ponding?	N/A	N/A	Gutter Slope (%)	N/A
N/A	Gutter Lip Ht (in)	N/A	N/A	Gutter X Slope (%)	N/A
N/A	Painted X Walk1?	No	N/A	Painted X Walk2?	No
	X Walk 1 Direction	To SW		X Walk 2 Direction	To SE
N/A	X Walk 1 Width (in)	N/A	N/A	X Walk 2 Width (in)	N/A
	X Walk 1 Slope (%)	4.2		X Walk 2 Slope (%)	1.4
	X Walk 1 X Slope (%)	1.2		X Walk 2 X Slope (%)	1.9

N/A	Ramp inside XWalk1?	N/A	N/A	Ramp inside XWalk2?	N/A
	Road Slope (%)	1.8	N/A	Clear Space?	N/A
	Road X Slope (%)	0.8	N/A	Clear Space to XWalk (in)	N/A
N/A	Any Obstructions?	N/A	N/A	Storm Grate/Utility Hazard?	N/A
	Obstruction Type			Storm Grate/Utility Type	
		N/A			N/A
			Yes	Surface Condition? (G/P)	Good

**Remove & Replace Curb Ramp With Two New Directional Ramps or Equivalent.**
