Access Compliance Report

Public Rights-of-Way

(Curb Ramps)

Intersection ID: 21311	Main Street: BURNT_MILL_RD	Cross Street: NORTHAMPTON_DR	Location: NW
ADA ID: 265E5E55BB9D	Ramp Type: PerpDiag	Initial Pass/Fail: Fail	Overall Compliance: No
			Severity Score: 33.75

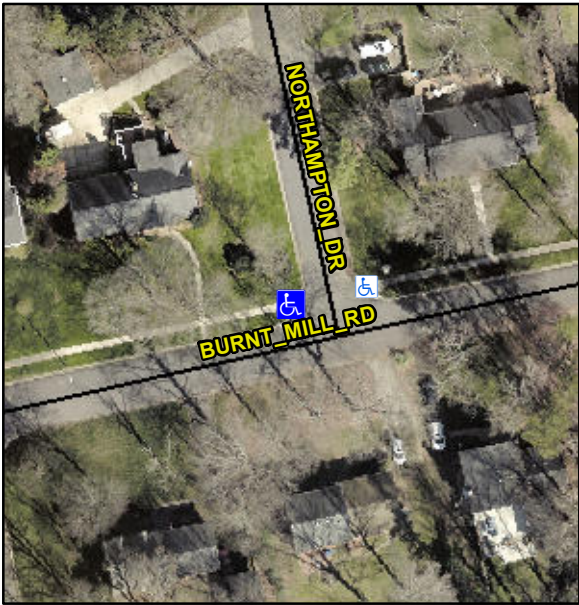
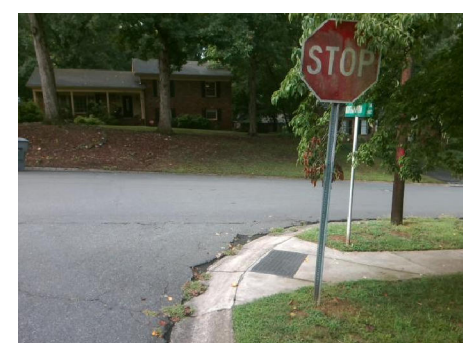
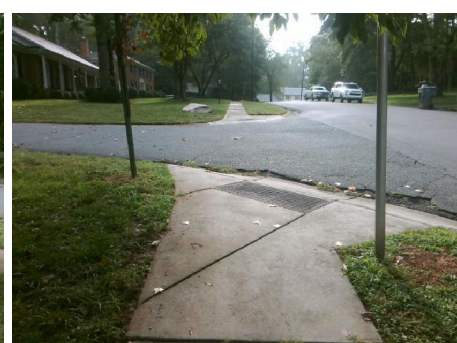
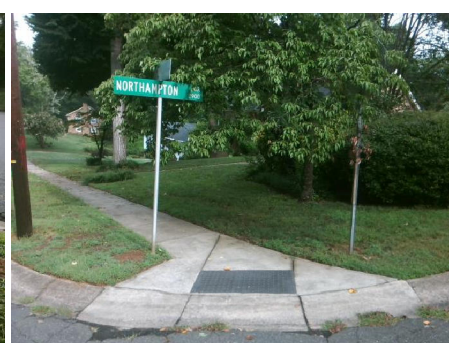
Possible Solutions:		Compliance	Description	Data	Compliance	Description	Data
	Remove & Replace Curb Ramp With Two New Directional Ramps or Equivalent.		N/A	Ramp Length (in)	47.0	Yes	Ramp Slope (%)	5.1
			No	Ramp Width (in)	47.5	No	Ramp XSlope (%)	11.2
			N/A	Flare Type LT	N/A	N/A	Flare Type RT	N/A
			N/A	Flare Slope LT (%)	N/A	N/A	Flare Slope RT (%)	N/A
			N/A	Flare Traversable LT?	N/A	N/A	Flare Traversable RT?	N/A
			N/A	Landing Length (in)	N/A	N/A	DWS Provided?	N/A
			N/A	Landing Width (in)	N/A	N/A	DWS Contrast?	N/A
			N/A	Landing Slope (%)	N/A	N/A	DWS Length (in)	N/A
			N/A	Landing X Slope (%)	N/A	N/A	DWS Full Width?	N/A
Surveyor Notes:		N/A	N/A	Landing Curb? (Y/N)	N/A	N/A	DWS Offset (in)	N/A
PROW/ADA:		Not Found, R304.5.1, R304.5.3	N/A	Shared Landing?	N/A			
			N/A	Gutter Ponding?	N/A	N/A	Gutter Slope (%)	N/A

N/A	Gutter Lip Ht (in)	N/A	N/A	Gutter X Slope (%)	N/A
			N/A	Painted X Walk1?	No	N/A	Painted X Walk2?	No
				X Walk 1 Direction	To S		X Walk 2 Direction	To E
			N/A	X Walk 1 Width (in)	N/A	N/A	X Walk 2 Width (in)	N/A
				X Walk 1 Slope (%)	3.2		X Walk 2 Slope (%)	11.6
				X Walk 1 X Slope (%)	13.5		X Walk 2 X Slope (%)	1.3
Street 1 Name		BURNT MILL RD	N/A	Ramp inside XWalk1?	N/A	N/A	Ramp inside XWalk2?	N/A
Stop Condition-Street 2		None		Road Slope (%)	9.0	N/A	Clear Space?	N/A
Street 2 Name		NORTHHAMPTON DR		Road X Slope (%)	9.3	N/A	Clear Space to XWalk (in)	N/A
Stop Condition-Street 1		StopSign	N/A	Any Obstructions?	N/A	N/A	Storm Grate/Utility Hazard?	N/A
				Obstruction Type			Storm Grate/Utility Type	
Total Cost:		\$ 3200.00			N/A			N/A
						Yes	Surface Condition? (G/P)	Good
