Access Compliance Report

Public Rights-of-Way

(Curb Ramps)

Intersection ID: 53284	Main Street: BENFIELD_RD	Cross Street: I-485_RA	Location: W
ADA ID: 269814326DC0	Ramp Type: Perp	Initial Pass/Fail: Fail	Overall Compliance: No
Severity Score: 13.75			
Codes/Mitigation Info/Possible Solution		Field Measurements/Component Compliance

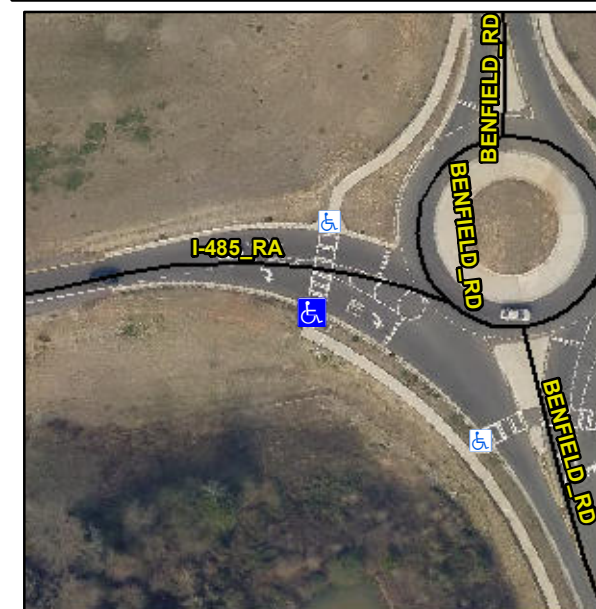
R304.2.2, R304.5.3

Compliance	Description	Data	Compliance	Description	Data
N/A	Ramp Length (in)	97.0	No	Ramp Slope (%)	8.9
Yes	Ramp Width (in)	48.0	No	Ramp XSlope (%)	3.0
N/A	Flare Type LT	N/A	N/A	Flare Type RT	N/A
N/A	Flare Slope LT (%)	N/A	N/A	Flare Slope RT (%)	N/A
N/A	Flare Traversable LT?	N/A	N/A	Flare Traversable RT?	N/A
N/A	Landing Length (in)	N/A	N/A	DWS Provided?	N/A
N/A	Landing Width (in)	N/A	N/A	DWS Contrast?	N/A
N/A	Landing Slope (%)	N/A	N/A	DWS Length (in)	N/A
N/A	Landing X Slope (%)	N/A	N/A	DWS Full Width?	N/A
N/A	Landing Curb? (Y/N)	N/A	N/A	DWS Offset (in)	N/A
N/A	Shared Landing?	N/A			
N/A	Gutter Ponding?	N/A	N/A	Gutter Slope (%)	N/A
N/A	Gutter Lip Ht (in)	N/A	N/A	Gutter X Slope (%)	N/A
N/A	Painted X Walk1?	Yes	N/A	Painted X Walk2?	N/A
	X Walk 1 Direction	To N		X Walk 2 Direction	N/A
N/A	X Walk 1 Width (in)	101.0	N/A	X Walk 2 Width (in)	N/A
	X Walk 1 Slope (%)	2.4		X Walk 2 Slope (%)	N/A
	X Walk 1 X Slope (%)	2.9		X Walk 2 X Slope (%)	N/A

Remove & Replace Entire Ramp.
