# Access Compliance Report

## Public Rights-of-Way

### (Curb Ramps)

Intersection ID: 26017	Main Street: CARMEL COMMONS BV	Cross Street: COPERNICUS CR	Location: S
ADA ID: 269FB6B80956	Ramp Type: PerpDiag	Initial Pass/Fail: Fail	Overall Compliance: No
		Severity Score: 37.5

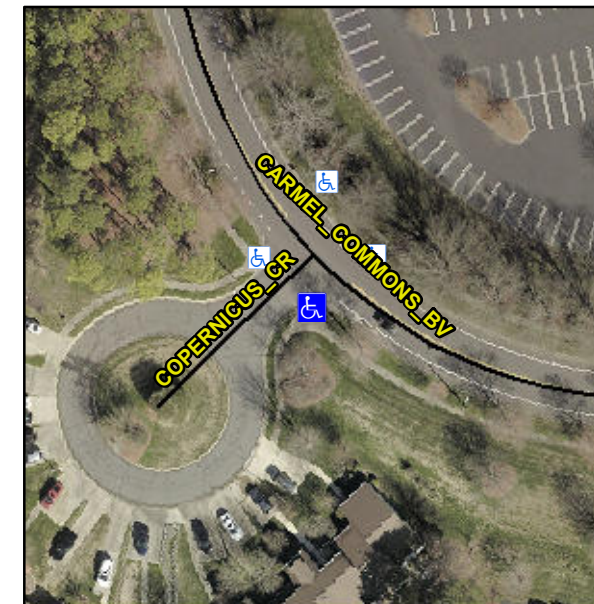
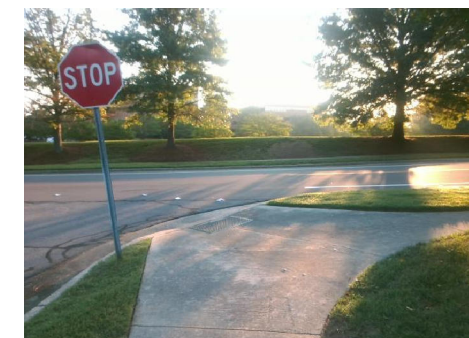
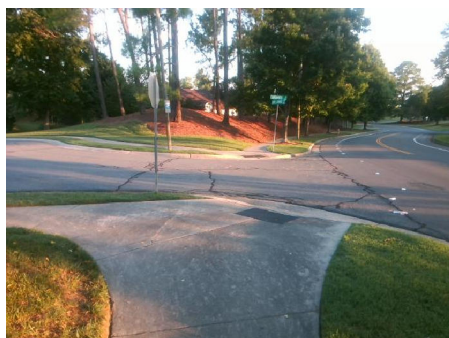
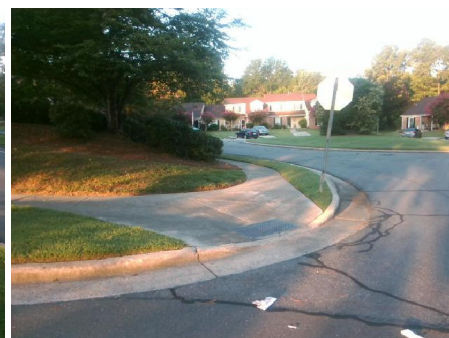
**R304.2.2, R304.5.3**

Compliance	Description	Data	Compliance	Description	Data
N/A	Ramp Length (in)	112.0	No	Ramp Slope (%)	8.7
Yes	Ramp Width (in)	54.0	No	Ramp XSlope (%)	10.5
N/A	Flare Type LT	N/A	N/A	Flare Type RT	N/A
N/A	Flare Slope LT (%)	N/A	N/A	Flare Slope RT (%)	N/A
N/A	Flare Traversable LT?	N/A	N/A	Flare Traversable RT?	N/A
N/A	Landing Length (in)	N/A	N/A	DWS Provided?	N/A
N/A	Landing Width (in)	N/A	N/A	DWS Contrast?	N/A
N/A	Landing Slope (%)	N/A	N/A	DWS Length (in)	N/A
N/A	Landing X Slope (%)	N/A	N/A	DWS Full Width?	N/A
N/A	Landing Curb? (Y/N)	N/A	N/A	DWS Offset (in)	N/A
N/A	Shared Landing?	N/A			
N/A	Gutter Ponding?	N/A	N/A	Gutter Slope (%)	N/A
N/A	Gutter Lip Ht (in)	N/A	N/A	Gutter X Slope (%)	N/A
N/A	Painted X Walk1?	No	N/A	Painted X Walk2?	No
	X Walk 1 Direction	To NE		X Walk 2 Direction	To NW
N/A	X Walk 1 Width (in)	N/A	N/A	X Walk 2 Width (in)	N/A
	X Walk 1 Slope (%)	0.5		X Walk 2 Slope (%)	3.3
	X Walk 1 X Slope (%)	3.6		X Walk 2 X Slope (%)	0.2

N/A	Ramp inside XWalk1?	N/A	N/A	Ramp inside XWalk2?	N/A
	Road Slope (%)	2.0	N/A	Clear Space?	N/A
	Road X Slope (%)	2.4	N/A	Clear Space to XWalk (in)	N/A
N/A	Any Obstructions?	N/A	N/A	Storm Grate/Utility Hazard?	N/A
	Obstruction Type			Storm Grate/Utility Type	
		N/A			N/A
		Yes		Surface Condition? (G/P)	Good

**Remove & Replace Curb Ramp With Two New Directional Ramps or Equivalent.**
