Access Compliance Report

Public Rights-of-Way

(Curb Ramps)

Intersection ID: 4977	Main Street: CARMATHEN_RD	Cross Street: CASTLEMAINE_DR	Location: SE
ADA ID: 26A53B9C5AE5	Ramp Type: Perp	Initial Pass/Fail: Fail	Overall Compliance: No
Severity Score: 33.75			
Codes/Mitigation Info/Possible Solution		Field Measurements/Component Compliance

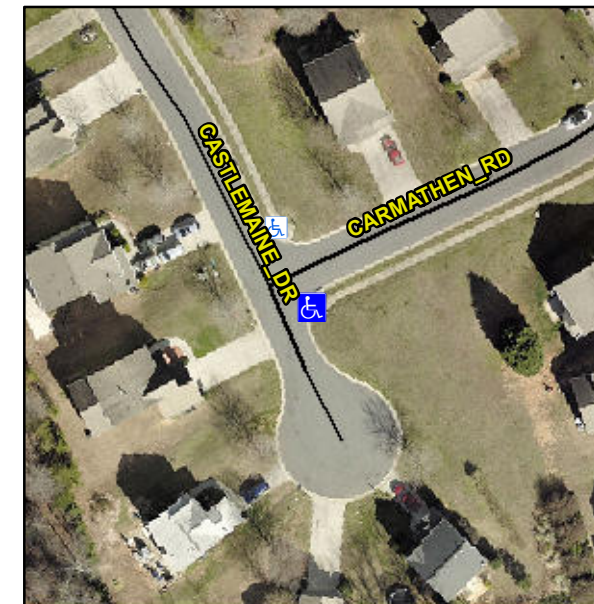
Not Found, R304.5.1, R304.5.3

Compliance	Description	Data	Compliance	Description	Data
N/A	Ramp Length (in)	47.0	Yes	Ramp Slope (%)	5.7
No	Ramp Width (in)	42.0	No	Ramp XSlope (%)	11.2
N/A	Flare Type LT	N/A	N/A	Flare Type RT	N/A
N/A	Flare Slope LT (%)	N/A	N/A	Flare Slope RT (%)	N/A
N/A	Flare Traversable LT?	N/A	N/A	Flare Traversable RT?	N/A
N/A	Landing Length (in)	N/A	N/A	DWS Provided?	N/A
N/A	Landing Width (in)	N/A	N/A	DWS Contrast?	N/A
N/A	Landing Slope (%)	N/A	N/A	DWS Length (in)	N/A
N/A	Landing X Slope (%)	N/A	N/A	DWS Full Width?	N/A
N/A	Landing Curb? (Y/N)	N/A	N/A	DWS Offset (in)	N/A
N/A	Shared Landing?	N/A			
N/A	Gutter Ponding?	N/A	N/A	Gutter Slope (%)	N/A
N/A	Gutter Lip Ht (in)	N/A	N/A	Gutter X Slope (%)	N/A
N/A	Painted X Walk1?	No	N/A	Painted X Walk2?	N/A
	X Walk 1 Direction	To N		X Walk 2 Direction	N/A
N/A	X Walk 1 Width (in)	N/A	N/A	X Walk 2 Width (in)	N/A
	X Walk 1 Slope (%)	4.5		X Walk 2 Slope (%)	N/A
	X Walk 1 X Slope (%)	8.0		X Walk 2 X Slope (%)	N/A

N/A	Ramp inside XWalk1?	N/A	N/A	Ramp inside XWalk2?	N/A
	Road Slope (%)	N/A	N/A	Clear Space?	N/A
	Road X Slope (%)	N/A	N/A	Clear Space to XWalk (in)	N/A
N/A	Any Obstructions?	N/A	N/A	Storm Grate/Utility Hazard?	N/A
	Obstruction Type			Storm Grate/Utility Type	
		N/A			N/A
			Yes	Surface Condition? (G/P)	Good

Possible Solutions:

Remove & Replace Entire Ramp.
