Access Compliance Report Public Rights-of-Way (Curb Ramps)

Intersection ID: 45550	ersection ID: 45550 Main Street: PEACHTREE_RD C					ross Street: ROOK RD			
ADA ID: 26ACB57F2773	Ramp Type: PerpDiag			Initial Pass/Fail: Fail Overall Compliance: No				Location: o Severity Score:	21 25
Codes/Mitigation Info/Possible Solution				Field Measurements/Component Compliance					
Possible Solutions:				· · · · ·

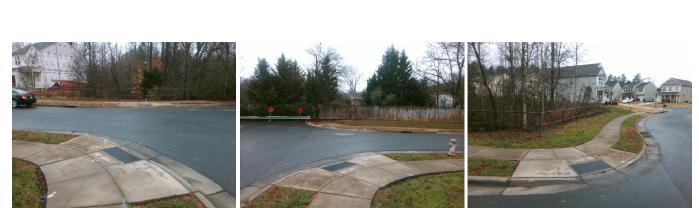
1. 1. 1. 1. 1. 1. 1. 1. 1. 1. 1. 1. 1. 1	S C C C C C C C C C C C C C C C C C C C			-					Data
		Remove & Replace Curb Ramp With Two New Directional Ramps or Equivalent.		N/A	Ramp Length (in)	49.5	No	Ramp Slope (%)	8.7
				No	Ramp Width (in)	38.5	Yes	Ramp XSlope (%)	0.6
				N/A	Flare Type LT	N/A	N/A	Flare Type RT	N/A
				N/A	Flare Slope LT (%)			Flare Slope RT (%)	N/A
				N/A	Flare Traversable LT?	N/A	N/A	Flare Traversable RT?	N/A
				N/A	Landing Length (in)	N/A	N/A	DWS Provided?	N/A
		Surveyor Notes:		N/A	Landing Width (in)	N/A	N/A	DWS Contrast?	N/A
		N/A		N/A	Landing Slope (%)	N/A	N/A	DWS Length (in)	N/A
		4		N/A	Landing X Slope (%)	N/A	N/A	DWS Full Width?	N/A
P AT AT AL				N/A	Landing Curb? (Y/N)	N/A	N/A	DWS Offset (in)	N/A
				N/A	Shared Landing?	N/A			
		PROW/ADA:		N/A	Gutter Ponding?	N/A	N/A	Gutter Slope (%)	N/A
		Not Found, R304.5.1, R304.2.2		N/A	Gutter Lip Ht (in)	1.5	N/A	Gutter X Slope (%)	N/A
