Access Compliance Report

Public Rights-of-Way

(Curb Ramps)

Intersection ID: 27963	Main Street: FAIR_ISLE_DR	Cross Street: MCGINN'S_TRACE_CT	Location: SE
ADA ID: 26C08891A982	Ramp Type: PerpDiag	Initial Pass/Fail: Fail	Overall Compliance: No
			Severity Score: 36.25

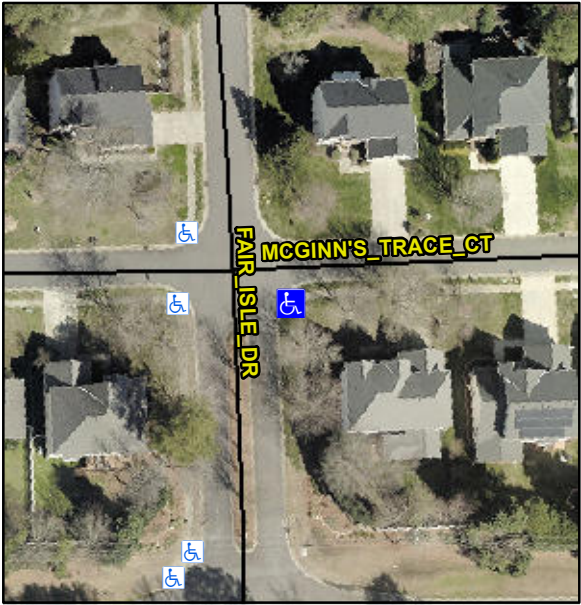
Surveyor Notes:		N/A	Ramp Length (in)	96.0
	N/A		No	Ramp Width (in)	25.0

Possible Solutions:		Compliance	Description	Data
	Remove & Replace Curb Ramp With Two New Directional Ramps or Equivalent.		Compliance	Description	Data
