# Access Compliance Report

## Public Rights-of-Way

### (Curb Ramps)

Intersection ID: 20929	Main Street: BASS_LN	Cross Street: KELFORD_LN	Location: S
ADA ID: 26C529742BA9	Ramp Type: PerpDiag	Initial Pass/Fail: Fail	Overall Compliance: No
Severity Score: 37.5			
Codes/Mitigation Info/Possible Solution		Field Measurements/Component Compliance

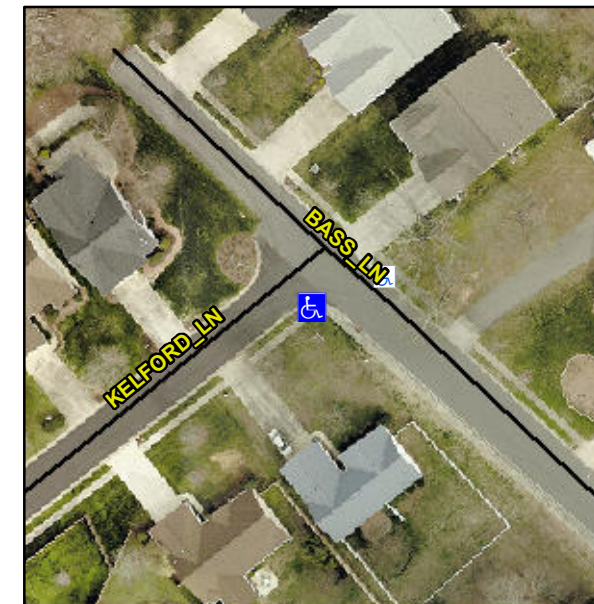
**Not Found, R304.2.2, R304.5.3**

Compliance	Description	Data	Compliance	Description	Data
N/A	Ramp Length (in)	42.0	No	Ramp Slope (%)	11.1
Yes	Ramp Width (in)	48.0	No	Ramp XSlope (%)	8.8
N/A	Flare Type LT	N/A	N/A	Flare Type RT	N/A
N/A	Flare Slope LT (%)	N/A	N/A	Flare Slope RT (%)	N/A
N/A	Flare Traversable LT?	N/A	N/A	Flare Traversable RT?	N/A
N/A	Landing Length (in)	N/A	N/A	DWS Provided?	N/A
N/A	Landing Width (in)	N/A	N/A	DWS Contrast?	N/A
N/A	Landing Slope (%)	N/A	N/A	DWS Length (in)	N/A
N/A	Landing X Slope (%)	N/A	N/A	DWS Full Width?	N/A
N/A	Landing Curb? (Y/N)	N/A	N/A	DWS Offset (in)	N/A
N/A	Shared Landing?	N/A			
N/A	Gutter Ponding?	N/A	N/A	Gutter Slope (%)	N/A
N/A	Gutter Lip Ht (in)	N/A	N/A	Gutter X Slope (%)	N/A
N/A	Painted X Walk1?	No	N/A	Painted X Walk2?	No
	X Walk 1 Direction	To E		X Walk 2 Direction	To NW
N/A	X Walk 1 Width (in)	N/A	N/A	X Walk 2 Width (in)	N/A
	X Walk 1 Slope (%)	4.0		X Walk 2 Slope (%)	5.8
	X Walk 1 X Slope (%)	4.5		X Walk 2 X Slope (%)	5.2

N/A	Ramp inside XWalk1?	N/A	N/A	Ramp inside XWalk2?	N/A
	Road Slope (%)	4.9	N/A	Clear Space?	N/A
	Road X Slope (%)	0.6	N/A	Clear Space to XWalk (in)	N/A
N/A	Any Obstructions?	N/A	N/A	Storm Grate/Utility Hazard?	N/A
	Obstruction Type			Storm Grate/Utility Type	
		N/A			N/A
		Yes		Surface Condition? (G/P)	Good

**Remove & Replace Curb Ramp With Two New Directional Ramps or Equivalent.**

Total Cost: \$ 3200.00
