Access Compliance Report Public Rights-of-Way (Curb Ramps)

-						
Intersection ID: 6357	Main Str	Main Street: CENTURY_OAKS_LN			Cross Street: WATERSTONE_LN				S
ADA ID: 26CBF89086F2	Ramp Ty	Ramp Type: Perp			Initial Pass/Fail: Fail Overall Compliance: No			Severity Score:	35
Codes/Mitigation Info/Possible Solution			Field Measurements/Component Compliance						
		Possible Solutions:		Compliance Description Data			Compliance Description Date		Data
		Remove & Replace	Entire Ramp.	N/A	Ramp Length (in)	47.0	No	Ramp Slope (%)	12.9
	1 1 1 1		-	No	Ramp Width (in)	39.0	No	Ramp XSlope (%)	4.9
				N/A	Flare Type LT	N/A	N/A	Flare Type RT	N/A
	TE .			N/A	Flare Slope LT (%)	N/A	N/A	Flare Slope RT (%)	N/A
				N/A	Flare Traversable LT?	N/A	N/A	Flare Traversable RT?	N/A

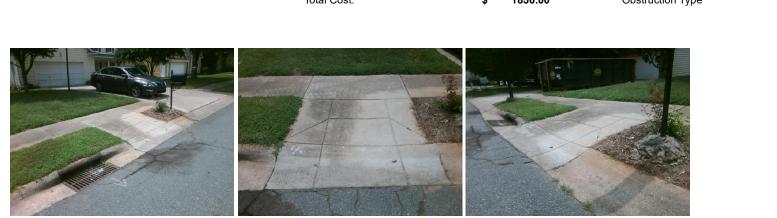
E.	and all a			N/A	Landing Length (in)	N/A	N/A	DWS Provided?	N/A
GENTURY_OAKS		Surveyor Notes:		N/A	Landing Width (in)	N/A	N/A	DWS Contrast?	N/A
<mark>6.</mark>	A Real Property in the second	N/A		N/A	Landing Slope (%)	N/A	N/A	DWS Length (in)	N/A
				N/A	Landing X Slope (%)	N/A	N/A	DWS Full Width?	N/A
ALL AND ALL AN	So the local			N/A	Landing Curb? (Y/N)	N/A	N/A	DWS Offset (in)	N/A
The setting the				N/A	Shared Landing?	N/A			
PROW/ADA:				N/A	Gutter Ponding?	N/A	N/A	Gutter Slope (%)	N/A
	Not Found, R304.5	.1. R304.2.2.	N/A	Gutter Lip Ht (in)	0.75	N/A	Gutter X Slope (%)	N/A	
Con Star (Con	R304.5.3	.,,	N/A	Painted X Walk1?	No	N/A	Painted X Walk2?	N/A	
I HAT THE WAY HAT I AND THE				X Walk 1 Direction	To N		X Walk 2 Direction	N/A	
				N/A	X Walk 1 Width (in)	N/A	N/A	X Walk 2 Width (in)	N/A
Street 1 Name CI	ENTURY OAKS LN	-			X Walk 1 Slope (%)	6.7		X Walk 2 Slope (%)	N/A
Stop Condition-Street 2	None				X Walk 1 X Slope (%)	3.6		X Walk 2 X Slope (%)	N/A

Street 2 Name	N/A			N/A	Ramp inside XWalk1?	N/A	N/A	Ramp inside XWalk2?	N/A
Stop Condition-Street 1	N/A				Road Slope (%)	N/A	N/A	Clear Space?	N/A
					Road X Slope (%)	N/A	N/A	Clear Space to XWalk (in)	N/A
				N/A	Any Obstructions?	N/A	N/A	Storm Grate/Utility Hazard?	N/A
		Total Cost:	\$ 18	50.00	Obstruction Type			Storm Grate/Utility Type	
						N/A			N/A
