Access Compliance Report

Public Rights-of-Way

(Curb Ramps)

Intersection ID: 27493	Main Street: DEERFIELD_CREEK_DR	Cross Street: FAWN_HILL_RD	Location: NW
ADA ID: 26D78F3919C9	Ramp Type: Perp	Initial Pass/Fail: Fail	Overall Compliance: No
Severity Score: 10			
Codes/Mitigation Info/Possible Solution		Field Measurements/Component Compliance

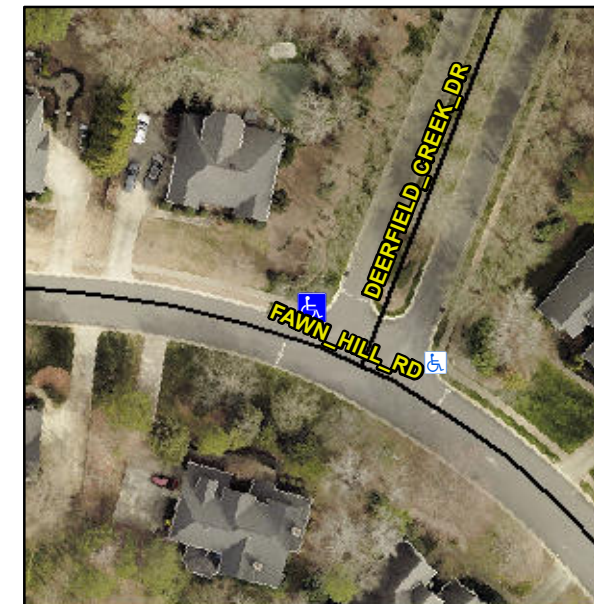
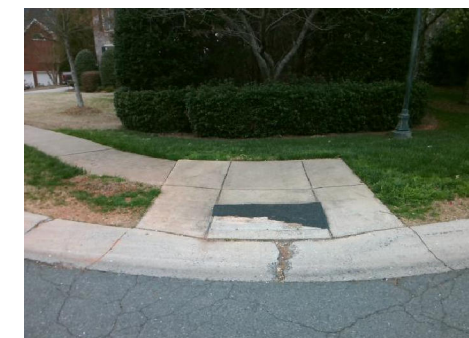
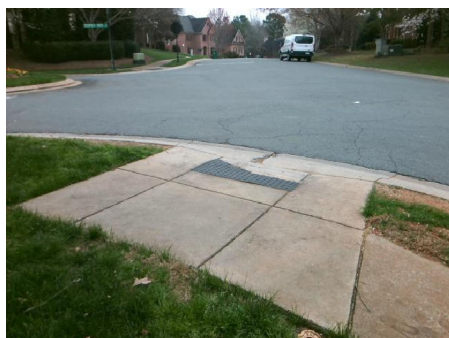
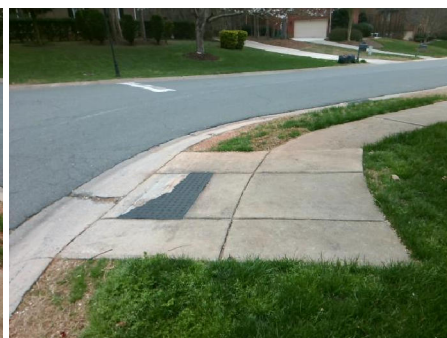
R304.5.1, R304.5.3

Compliance	Description	Data	Compliance	Description	Data
N/A	Ramp Length (in)	48.5	Yes	Ramp Slope (%)	6.5
No	Ramp Width (in)	45.5	No	Ramp XSlope (%)	4.7
N/A	Flare Type LT	N/A	N/A	Flare Type RT	N/A
N/A	Flare Slope LT (%)	N/A	N/A	Flare Slope RT (%)	N/A
N/A	Flare Traversable LT?	N/A	N/A	Flare Traversable RT?	N/A
N/A	Landing Length (in)	N/A	N/A	DWS Provided?	N/A
N/A	Landing Width (in)	N/A	N/A	DWS Contrast?	N/A
N/A	Landing Slope (%)	N/A	N/A	DWS Length (in)	N/A
N/A	Landing X Slope (%)	N/A	N/A	DWS Full Width?	N/A
N/A	Landing Curb? (Y/N)	N/A	N/A	DWS Offset (in)	N/A
N/A	Shared Landing?	N/A			
N/A	Gutter Ponding?	N/A	N/A	Gutter Slope (%)	N/A
N/A	Gutter Lip Ht (in)	N/A	N/A	Gutter X Slope (%)	N/A
N/A	Painted X Walk1?	No	N/A	Painted X Walk2?	N/A
	X Walk 1 Direction	To SE		X Walk 2 Direction	N/A
N/A	X Walk 1 Width (in)	N/A	N/A	X Walk 2 Width (in)	N/A
	X Walk 1 Slope (%)	7.3		X Walk 2 Slope (%)	N/A
	X Walk 1 X Slope (%)	1.1		X Walk 2 X Slope (%)	N/A

N/A	Ramp inside XWalk1?	N/A	N/A	Ramp inside XWalk2?	N/A
	Road Slope (%)	N/A	N/A	Clear Space?	N/A
	Road X Slope (%)	N/A	N/A	Clear Space to XWalk (in)	N/A
N/A	Any Obstructions?	N/A	N/A	Storm Grate/Utility Hazard?	N/A
	Obstruction Type			Storm Grate/Utility Type	
		N/A			N/A
			Yes	Surface Condition? (G/P)	Good

Remove & Replace Entire Ramp.
