# Access Compliance Report

## Public Rights-of-Way

Intersection ID: 54325	Main Street: CANTERBURY CASTLE DR	Cross Street: ROCKY HILL CASTLE DR	Location: NW
ADA ID: 26EE503779F1	Ramp Type: BlendTrans1	Initial Pass/Fail: Fail	Overall Compliance: No
		Severity Score: 10

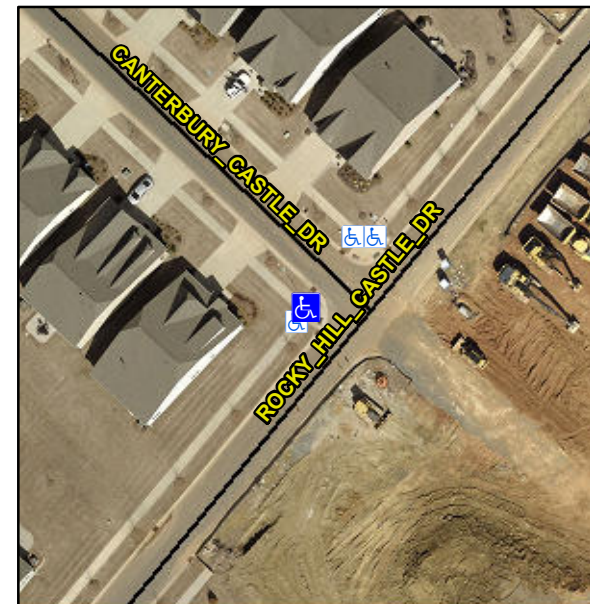
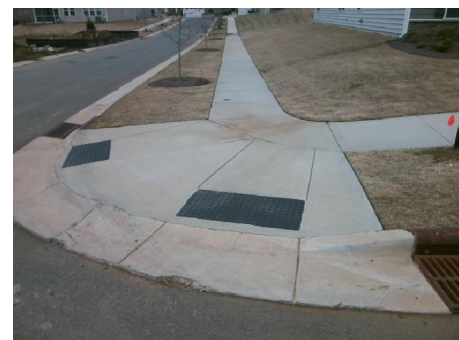
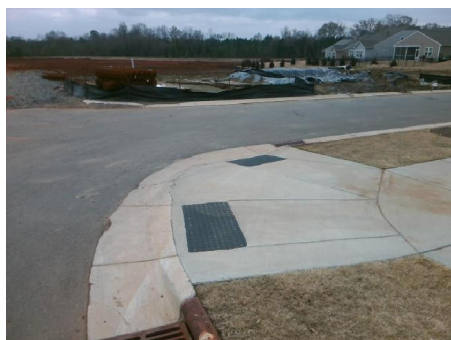
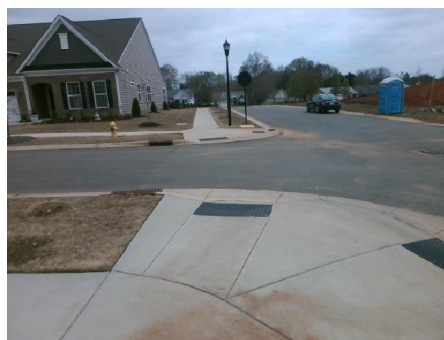
Compliance	Description	Data	Compliance	Description	Data
N/A	Ramp Length (in)	97.0	Yes	BlendTrans Slope (%)	3.6
No	Ramp Width (in)	40.0	No	BlendTrans XSlope (%)	4.8
N/A	Flare Type LT	N/A	N/A	Flare Type RT	N/A
N/A	Flare Slope LT (%)	N/A	N/A	Flare Slope RT (%)	N/A
N/A	Flare Traversable LT?	N/A	N/A	Flare Traversable RT?	N/A
N/A	Landing Length (in)	N/A	N/A	DWS Provided?	N/A
N/A	Landing Width (in)	N/A	N/A	DWS Contrast?	N/A
N/A	Landing Slope (%)	N/A	N/A	DWS Length (in)	N/A
N/A	Landing X Slope (%)	N/A	N/A	DWS Full Width?	N/A
N/A	Landing Curb? (Y/N)	N/A	N/A	DWS Offset (in)	N/A
N/A	Shared Landing?	N/A			
N/A	Gutter Ponding?	N/A	N/A	Gutter Slope (%)	N/A
N/A	Gutter Lip Ht (in)	1.0	N/A	Gutter X Slope (%)	N/A
N/A	Painted X Walk1?	No	N/A	Painted X Walk2?	N/A
	X Walk 1 Direction	To NE		X Walk 2 Direction	N/A
	X Walk 1 Width (in)	N/A		X Walk 2 Width (in)	N/A
	X Walk 1 Slope (%)	1.1		X Walk 2 Slope (%)	N/A
	X Walk 1 X Slope (%)	2.8		X Walk 2 X Slope (%)	N/A

N/A	Ramp inside XWalk1?	N/A	N/A	Ramp inside XWalk2?	N/A
	Road Slope (%)	2.8		Clear Space?	N/A
	Road X Slope (%)	1.1	N/A	Clear Space to XWalk (in)	N/A
N/A	Any Obstructions?	N/A	N/A	Storm Grate/Utility Hazard?	N/A
	Obstruction Type			Storm Grate/Utility Type	
		N/A			N/A
			Yes	Surface Condition? (G/P)	Good
			N/A	Curb Slope (%)	4.6

**Remove & Replace Curb Ramp With Two New Directional Ramps or Equivalent.**

**R304.5.1, R304.5.3**
