Access Compliance Report

Public Rights-of-Way

(Curb Ramps)

Intersection ID: 10020721	Main Street: BEATTIES_FORD_RD	Cross Street: BEATTIES_FORD_RD	Location: E
ADA ID: 26FB18316768	Ramp Type: Perp	Initial Pass/Fail: Pass	Overall Compliance: No
			Severity Score: 15.25

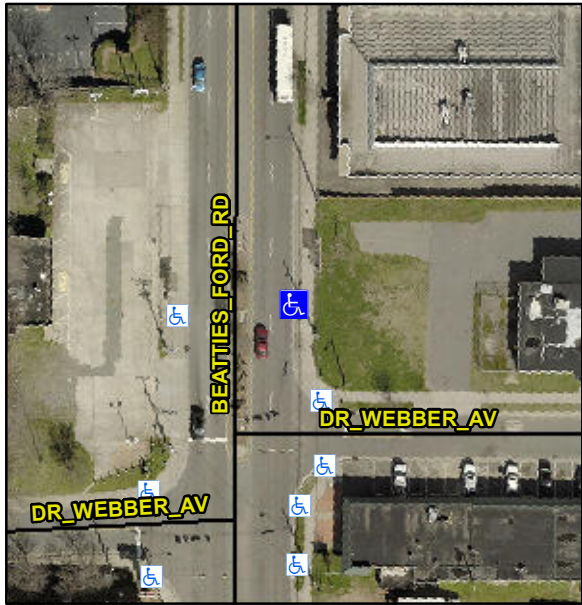
Possible Solutions:		Compliance			Description			Data	Compliance			Description			Data
	Remove & Replace Entire Ramp.		N/A	Ramp Length (in)			106.0			Yes	Ramp Slope (%)			6.8		
	Remove & Replace Gutter.		Yes	Ramp Width (in)			48.0			No	Ramp XSlope (%)			2.1		
			N/A	Flare Type LT			Sloped			N/A	Flare Type RT			N/A		
			N/A	Flare Slope LT (%)			7.7			Yes	Flare Slope RT (%)			4.9		
			N/A	Flare Traversable LT?			Yes			N/A	Flare Traversable RT?			Yes		
			No	Landing Length (in)			N/A			Yes	DWS Provided?			Yes		
			No	Landing Width (in)			N/A			Yes	DWS Contrast?			Yes		
			No	Landing Slope (%)			N/A			Yes	DWS Length (in)			24.0		
			No	Landing X Slope (%)			N/A			Yes	DWS Full Width?			Yes		
Surveyor Notes:		N/A	N/A	Landing Curb? (Y/N)			No			Yes	DWS Offset (in)			0.0		
		N/A	N/A	Shared Landing?			No									
PROW/ADA:		Not Found, R304.5.3, R304.2.1, R304.2.2-Perp, R304.3.2-Para, R304.5.4	Yes	Gutter Ponding?			No			No	Gutter Slope (%)			7.5

Yes	Gutter Lip Ht (in)			0.0			Yes	Gutter X Slope (%)			1.3		
			N/A	Painted X Walk1?			No			N/A	Painted X Walk2?			N/A		
				X Walk 1 Direction			To W				X Walk 2 Direction			N/A		
			N/A	X Walk 1 Width (in)			N/A			N/A	X Walk 2 Width (in)			N/A		
				X Walk 1 Slope (%)			3.0				X Walk 2 Slope (%)			N/A		
				X Walk 1 X Slope (%)			0.9				X Walk 2 X Slope (%)			N/A		
			N/A	Ramp inside XWalk1?			N/A			N/A	Ramp inside XWalk2?			N/A		
				Road Slope (%)			N/A			N/A	Clear Space?			Yes		
				Road X Slope (%)			N/A			N/A	Clear Space to XWalk (in)			N/A		
			Yes	Any Obstructions?			No			Yes	Storm Grate/Utility Hazard?			No		
				Obstruction Type							Storm Grate/Utility Type					
										N/A				N/A		
										Yes	Surface Condition? (G/P)			Good		
Total Cost:		\$ 2600.00
