# Access Compliance Report

## Public Rights-of-Way

### (Curb Ramps)

Intersection ID: 30443	Main Street: CADES_COVE_DR	Cross Street: ELM_BEND_DR	Location:	N
ADA ID: 2709BFFFFB47E	Ramp Type: PerpDiag	Initial Pass/Fail: Fail	Overall Compliance: No	Severity Score: 12.5

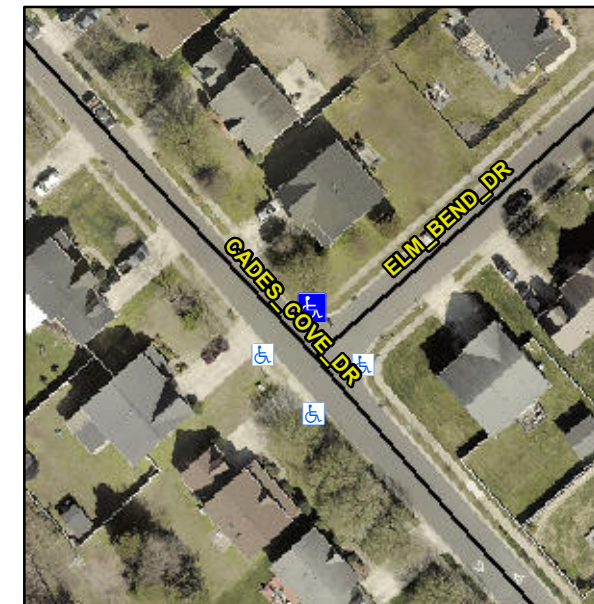
Compliance	Description	Data	Compliance	Description	Data
N/A	Ramp Length (in)	46.0	Yes	Ramp Slope (%)	6.9
Yes	Ramp Width (in)	48.0	No	Ramp XSlope (%)	6.2
N/A	Flare Type LT	N/A	N/A	Flare Type RT	N/A
N/A	Flare Slope LT (%)	N/A	N/A	Flare Slope RT (%)	N/A
N/A	Flare Traversable LT?	N/A	N/A	Flare Traversable RT?	N/A
N/A	Landing Length (in)	N/A	N/A	DWS Provided?	N/A
N/A	Landing Width (in)	N/A	N/A	DWS Contrast?	N/A
N/A	Landing Slope (%)	N/A	N/A	DWS Length (in)	N/A
N/A	Landing X Slope (%)	N/A	N/A	DWS Full Width?	N/A
N/A	Landing Curb? (Y/N)	N/A	N/A	DWS Offset (in)	N/A
N/A	Shared Landing?	N/A			
N/A	Gutter Ponding?	N/A	N/A	Gutter Slope (%)	N/A
N/A	Gutter Lip Ht (in)	N/A	N/A	Gutter X Slope (%)	N/A
N/A	Painted X Walk1?	No	N/A	Painted X Walk2?	No
	X Walk 1 Direction	To SW		X Walk 2 Direction	To SE
N/A	X Walk 1 Width (in)	N/A	N/A	X Walk 2 Width (in)	N/A
	X Walk 1 Slope (%)	3.4		X Walk 2 Slope (%)	0.1
	X Walk 1 X Slope (%)	1.2		X Walk 2 X Slope (%)	1.9

N/A	Ramp inside XWalk1?	N/A	N/A	Ramp inside XWalk2?	N/A
	Road Slope (%)	2.8	N/A	Clear Space?	N/A
	Road X Slope (%)	4.0	N/A	Clear Space to XWalk (in)	N/A
N/A	Any Obstructions?	N/A	N/A	Storm Grate/Utility Hazard?	N/A
	Obstruction Type			Storm Grate/Utility Type	
		N/A			N/A
		Yes		Surface Condition? (G/P)	Good

**Remove & Replace Curb Ramp With Two New Directional Ramps or Equivalent.**

**R304.5.3**
