Access Compliance Report

Public Rights-of-Way

(Curb Ramps)

Intersection ID: 28344	Main Street: BELLHAVEN_WALK_CT	Cross Street: BRIDGEHAMPTON_CLUB_DR	Location: NW
ADA ID: 270AB6668BFC	Ramp Type: Perp	Initial Pass/Fail: Fail	Overall Compliance: No
Severity Score: 25			
Codes/Mitigation Info/Possible Solution		Field Measurements/Component Compliance

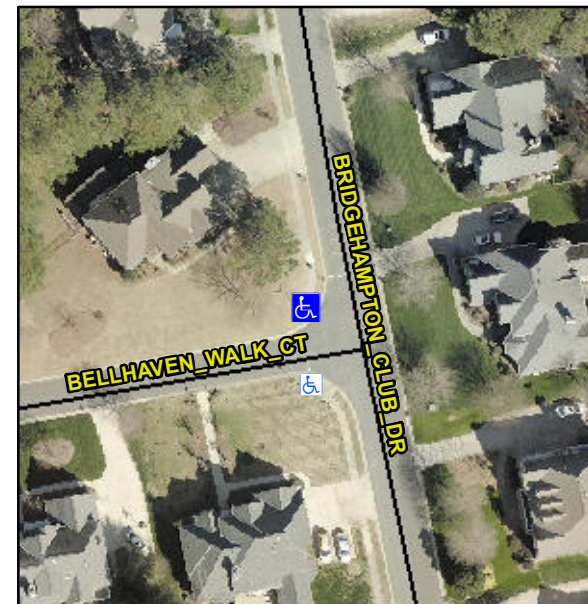
Not Found, R304.5.3

Compliance	Description	Data	Compliance	Description	Data
N/A	Ramp Length (in)	47.0	Yes	Ramp Slope (%)	7.5
Yes	Ramp Width (in)	49.0	No	Ramp XSlope (%)	7.2
N/A	Flare Type LT	N/A	N/A	Flare Type RT	N/A
N/A	Flare Slope LT (%)	N/A	N/A	Flare Slope RT (%)	N/A
N/A	Flare Traversable LT?	N/A	N/A	Flare Traversable RT?	N/A
N/A	Landing Length (in)	N/A	N/A	DWS Provided?	N/A
N/A	Landing Width (in)	N/A	N/A	DWS Contrast?	N/A
N/A	Landing Slope (%)	N/A	N/A	DWS Length (in)	N/A
N/A	Landing X Slope (%)	N/A	N/A	DWS Full Width?	N/A
N/A	Landing Curb? (Y/N)	N/A	N/A	DWS Offset (in)	N/A
N/A	Shared Landing?	N/A			
N/A	Gutter Ponding?	N/A	N/A	Gutter Slope (%)	N/A
N/A	Gutter Lip Ht (in)	N/A	N/A	Gutter X Slope (%)	N/A
N/A	Painted X Walk1?	No	N/A	Painted X Walk2?	N/A
	X Walk 1 Direction	To S		X Walk 2 Direction	N/A
N/A	X Walk 1 Width (in)	N/A	N/A	X Walk 2 Width (in)	N/A
	X Walk 1 Slope (%)	0.3		X Walk 2 Slope (%)	N/A
	X Walk 1 X Slope (%)	2.0		X Walk 2 X Slope (%)	N/A

Remove & Replace Entire Ramp.

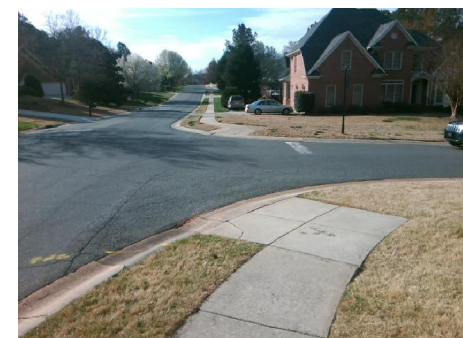
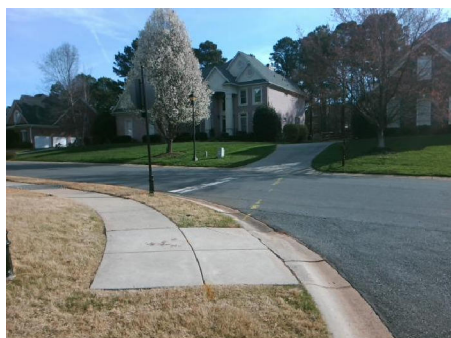
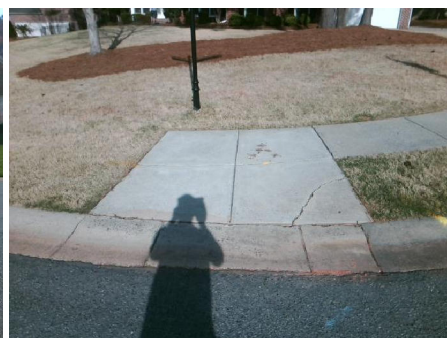
N/A	Ramp inside XWalk1?	N/A	N/A	Ramp inside XWalk2?	N/A
	Road Slope (%)	N/A	N/A	Clear Space?	N/A
	Road X Slope (%)	N/A	N/A	Clear Space to XWalk (in)	N/A
N/A	Any Obstructions?	N/A	N/A	Storm Grate/Utility Hazard?	N/A
	Obstruction Type			Storm Grate/Utility Type	
		N/A			N/A
		Yes		Surface Condition? (G/P)	Good
