Access Compliance Report

Public Rights-of-Way

(Curb Ramps)

Intersection ID: 24343	Main Street: BIRNEN_DR	Cross Street: LANDSBURG_LN	Location: NE
ADA ID: 2721692E85A8	Ramp Type: PerpDiag	Initial Pass/Fail: Fail	Overall Compliance: No
		Severity Score: 10

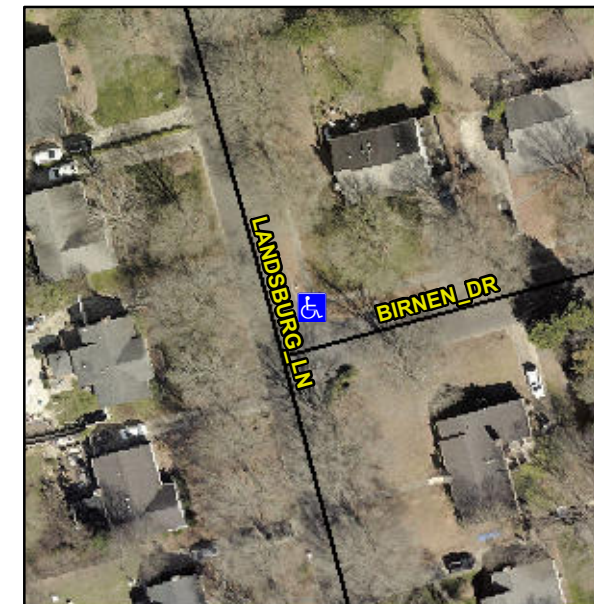
Not Found, R304.5.1, R304.5.3

Compliance	Description	Data	Compliance	Description	Data
N/A	Ramp Length (in)	68.0	Yes	Ramp Slope (%)	6.1
No	Ramp Width (in)	40.0	No	Ramp XSlope (%)	4.4
N/A	Flare Type LT	N/A	N/A	Flare Type RT	N/A
N/A	Flare Slope LT (%)	N/A	N/A	Flare Slope RT (%)	N/A
N/A	Flare Traversable LT?	N/A	N/A	Flare Traversable RT?	N/A
N/A	Landing Length (in)	N/A	N/A	DWS Provided?	N/A
N/A	Landing Width (in)	N/A	N/A	DWS Contrast?	N/A
N/A	Landing Slope (%)	N/A	N/A	DWS Length (in)	N/A
N/A	Landing X Slope (%)	N/A	N/A	DWS Full Width?	N/A
N/A	Landing Curb? (Y/N)	N/A	N/A	DWS Offset (in)	N/A
N/A	Shared Landing?	N/A			
N/A	Gutter Ponding?	N/A	N/A	Gutter Slope (%)	N/A
N/A	Gutter Lip Ht (in)	N/A	N/A	Gutter X Slope (%)	N/A
N/A	Painted X Walk1?	No	N/A	Painted X Walk2?	No
	X Walk 1 Direction	To W		X Walk 2 Direction	To S
N/A	X Walk 1 Width (in)	N/A	N/A	X Walk 2 Width (in)	N/A
	X Walk 1 Slope (%)	1.4		X Walk 2 Slope (%)	1.2
	X Walk 1 X Slope (%)	2.0		X Walk 2 X Slope (%)	2.0

N/A	Ramp inside XWalk1?	N/A	N/A	Ramp inside XWalk2?	N/A
	Road Slope (%)	3.3	N/A	Clear Space?	N/A
	Road X Slope (%)	1.3	N/A	Clear Space to XWalk (in)	N/A
N/A	Any Obstructions?	N/A	N/A	Storm Grate/Utility Hazard?	N/A
	Obstruction Type			Storm Grate/Utility Type	
		N/A			N/A
			Yes	Surface Condition? (G/P)	Good

Remove & Replace Curb Ramp With Two New Directional Ramps or Equivalent.

Total Cost: \$ 3200.00
