Access Compliance Report Public Rights-of-Way (Curb Ramps)

Intersection ID: 10031496 Main Street: MCKEE_RD Cross Street: N/A Location: SW

ADA ID: 27230BFE9180 Ramp Type: BlendTrans2 Initial Pass/Fail: Pass Overall Compliance: Yes Severity Score: 0

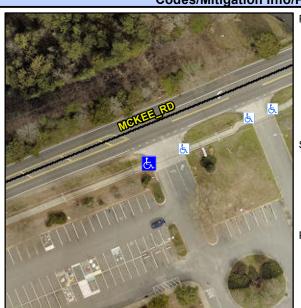
Compliance Description		Data	Comp	liance Description	Data
N/A	Ramp Length (in)	71.0	Yes	BlendTrans Slope (%)	0.5
Yes	Ramp Width (in)	71.0	Yes	BlendTrans XSlope (%)	0.9
N/A	Flare Type LT	None	N/A	Flare Type RT	None
N/A	Flare Slope LT (%)	N/A	N/A	Flare Slope RT (%)	N/A
N/A	Flare Traversable LT?	N/A	N/A	Flare Traversable RT?	N/A
N/A	Landing Length (in)	N/A	Yes	DWS Provided?	Yes
N/A	Landing Width (in)	N/A	Yes	DWS Contrast?	Yes
N/A	Landing Slope (%)	N/A	Yes	DWS Length (in)	24.0
N/A	Landing X Slope (%)	N/A	Yes	DWS Full Width?	Yes
N/A	Landing Curb? (Y/N)	No	Yes	DWS Offset (in)	0.0
N/A	Shared Landing?	No			
Yes	Gutter Ponding?	No	Yes	Gutter Slope (%)	1.7
Yes	Gutter Lip Ht (in)	0.0	Yes	Gutter X Slope (%)	1.0
N/A	Painted X Walk1?	No	N/A	Painted X Walk2?	N/A
	X Walk 1 Direction	To NE		X Walk 2 Direction	N/A
	X Walk 1 Width (in)	N/A		X Walk 2 Width (in)	N/A
	X Walk 1 Slope (%)	1.3		X Walk 2 Slope (%)	N/A
	X Walk 1 X Slope (%)	0.1		X Walk 2 X Slope (%)	N/A

N/A	Ramp inside XWalk1?	N/A	N/A	Ramp inside XWalk2?	N/A
	Road Slope (%)	0.1		Clear Space?	Yes
	Road X Slope (%)	1.3	N/A	Clear Space to XWalk (in)	N/A
Yes	Any Obstructions?	No	Yes	Storm Grate/Utility Hazard?	No
	Obstruction Type			Storm Grate/Utility Type	
		N/A			N/A
			Yes	Surface Condition? (G/P)	Good
