Access Compliance Report Public Rights-of-Way (Curb Ramps)

Intersection ID: 9015 Main Street: DEWOLFE_ST **Cross Street: TILLMAN RD** Location: **Overall Compliance: No** ADA ID: 274737100EBC Ramp Type: BlendTrans2 Initial Pass/Fail: Fail **Severity Score:** 10

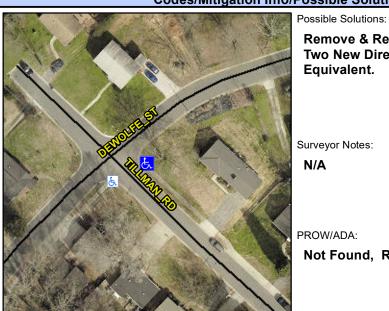
Not Found, R304.5.1, R304.5.3

Comp	liance Description	Data	Comp	liance Description	Data
N/A	Ramp Length (in)	106.0	Yes	BlendTrans Slope (%)	2.8
No	Ramp Width (in)	46.0	No	BlendTrans XSlope (%)	3.3
N/A	Flare Type LT	N/A	N/A	Flare Type RT	N/A
N/A	Flare Slope LT (%)	N/A	N/A	Flare Slope RT (%)	N/A
N/A	Flare Traversable LT?	N/A	N/A	Flare Traversable RT?	N/A
N/A	Landing Length (in)	N/A	N/A	DWS Provided?	N/A
N/A	Landing Width (in)	N/A	N/A	DWS Contrast?	N/A
N/A	Landing Slope (%)	N/A	N/A	DWS Length (in)	N/A
N/A	Landing X Slope (%)	N/A	N/A	DWS Full Width?	N/A
N/A	Landing Curb? (Y/N)	N/A	N/A	DWS Offset (in)	N/A
N/A	Shared Landing?	N/A			
N/A	Gutter Ponding?	N/A	N/A	Gutter Slope (%)	N/A
N/A	Gutter Lip Ht (in)	N/A	N/A	Gutter X Slope (%)	N/A
N/A	Painted X Walk1?	No	N/A	Painted X Walk2?	N/A
	X Walk 1 Direction	To SW		X Walk 2 Direction	N/A
	X Walk 1 Width (in)	N/A		X Walk 2 Width (in)	N/A
	X Walk 1 Slope (%)	3.8		X Walk 2 Slope (%)	N/A
	X Walk 1 X Slope (%)	1.7		X Walk 2 X Slope (%)	N/A

N/A	Ramp inside XWalk1?	N/A	N/A	Ramp inside XWalk2?	N/A
	Road Slope (%)	1.7		Clear Space?	N/A
	Road X Slope (%)	3.8	N/A	Clear Space to XWalk (in)	N/A
N/A	Any Obstructions?	N/A	N/A	Storm Grate/Utility Hazard?	N/A
	Obstruction Type			Storm Grate/Utility Type	
		N/A			N/A
			Yes	Surface Condition? (G/P)	Good
3-11: 0 13:11 0 13:11 1			No	Curb Slope (%)	11.5

TILLMAN RD Street 1 Name Stop Condition-Street 1 StopSign Street 2 Name N/A Stop Condition-Street 2 N/A Remove & Replace Curb Ramp With **Two New Directional Ramps or** Equivalent.
