Access Compliance Report

Public Rights-of-Way

(Curb Ramps)

Intersection ID: 46026	Main Street: BITTINGER_CT	Cross Street: PAULINE_LN	Location: NW
ADA ID: 275540BB589F	Ramp Type: BlendTrans2	Initial Pass/Fail: Fail	Overall Compliance: No
		Severity Score: 12.5

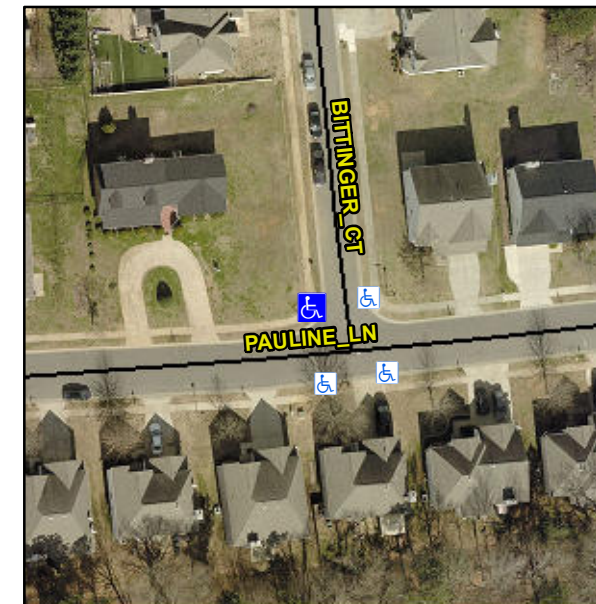
Not Found, R304.5.3

Compliance	Description	Data	Compliance	Description	Data
N/A	Ramp Length (in)	96.0	Yes	BlendTrans Slope (%)	2.3
Yes	Ramp Width (in)	80.0	No	BlendTrans XSlope (%)	5.9
N/A	Flare Type LT	N/A	N/A	Flare Type RT	N/A
N/A	Flare Slope LT (%)	N/A	N/A	Flare Slope RT (%)	N/A
N/A	Flare Traversable LT?	N/A	N/A	Flare Traversable RT?	N/A
N/A	Landing Length (in)	N/A	N/A	DWS Provided?	N/A
N/A	Landing Width (in)	N/A	N/A	DWS Contrast?	N/A
N/A	Landing Slope (%)	N/A	N/A	DWS Length (in)	N/A
N/A	Landing X Slope (%)	N/A	N/A	DWS Full Width?	N/A
N/A	Landing Curb? (Y/N)	N/A	N/A	DWS Offset (in)	N/A
N/A	Shared Landing?	N/A			
N/A	Gutter Ponding?	N/A	N/A	Gutter Slope (%)	N/A
N/A	Gutter Lip Ht (in)	N/A	N/A	Gutter X Slope (%)	N/A
N/A	Painted X Walk1?	No	N/A	Painted X Walk2?	No
	X Walk 1 Direction	To S		X Walk 2 Direction	To E
	X Walk 1 Width (in)	N/A		X Walk 2 Width (in)	N/A
	X Walk 1 Slope (%)	1.4		X Walk 2 Slope (%)	4.4
	X Walk 1 X Slope (%)	4.6		X Walk 2 X Slope (%)	0.6

N/A	Ramp inside XWalk1?	N/A	N/A	Ramp inside XWalk2?	N/A
	Road Slope (%)	3.5		Clear Space?	N/A
	Road X Slope (%)	3.1	N/A	Clear Space to XWalk (in)	N/A
N/A	Any Obstructions?	N/A	N/A	Storm Grate/Utility Hazard?	N/A
	Obstruction Type			Storm Grate/Utility Type	
		N/A			N/A
			Yes	Surface Condition? (G/P)	Good
			No	Curb Slope (%)	19.9

Remove & Replace Curb Ramp With Two New Directional Ramps or Equivalent.
