# Access Compliance Report

## Public Rights-of-Way

### (Curb Ramps)

Intersection ID: 6314	Main Street: BARN_BOARD_LN	Cross Street: WATERSTONE_LN	Location: E
ADA ID: 275BBCE7B515	Ramp Type: Perp	Initial Pass/Fail: Fail	Overall Compliance: No
			Severity Score: 26.25

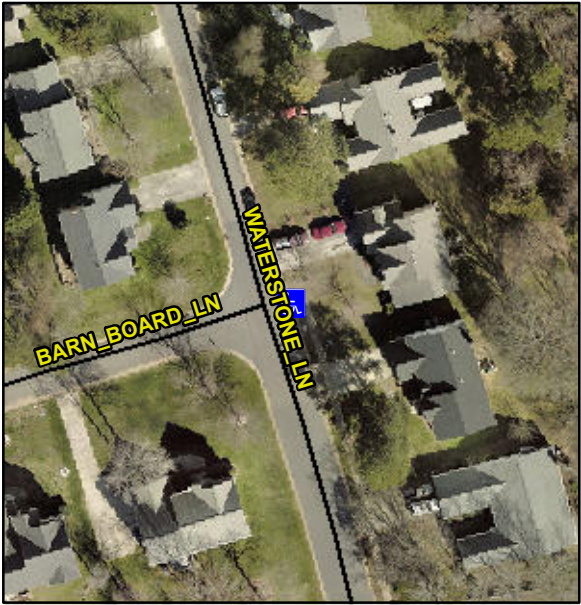
Possible Solutions:		<b>Compliance</b>	<b>Description</b>	<b>Data</b>
	<b>Remove &amp; Replace Entire Ramp.</b>		<b>No</b>	Ramp Length (in)	46.0
			<b>Yes</b>	Ramp Width (in)	48.0
			<b>N/A</b>	Flare Type LT	N/A
			<b>N/A</b>	Flare Slope LT (%)	N/A
			<b>N/A</b>	Flare Traversable LT?	N/A
			<b>N/A</b>	Landing Length (in)	N/A
			<b>N/A</b>	Landing Width (in)	N/A
			<b>N/A</b>	Landing Slope (%)	N/A
			<b>N/A</b>	Landing X Slope (%)	N/A
<p>Surveyor Notes:</p> <p><b>N/A</b></p> <p>PROW/ADA:</p> <p><b>Not Found, R304.2.2</b></p>			<b>N/A</b>	Flare Type RT	N/A
			<b>N/A</b>	Flare Slope RT (%)	N/A
			<b>N/A</b>	Flare Traversable RT?	N/A
			<b>N/A</b>	DWS Provided?	N/A
			<b>N/A</b>	DWS Contrast?	N/A
			<b>N/A</b>	DWS Length (in)	N/A
			<b>N/A</b>	DWS Full Width?	N/A
			<b>N/A</b>	DWS Offset (in)	N/A
			<b>N/A</b>	Shared Landing?	N/A

<b>N/A</b>	Gutter Ponding?	N/A
			<b>N/A</b>	Gutter Lip Ht (in)	N/A
			<b>N/A</b>	Painted X Walk1?	No
				X Walk 1 Direction	To W
			<b>N/A</b>	X Walk 1 Width (in)	N/A
				X Walk 1 Slope (%)	5.0
				X Walk 1 X Slope (%)	2.5
			<b>N/A</b>	Ramp inside XWalk1?	N/A
			<b>N/A</b>	Road Slope (%)	N/A
			<b>N/A</b>	Road X Slope (%)	N/A
			<b>N/A</b>	Any Obstructions?	N/A
				Obstruction Type	
			<b>N/A</b>		
			<b>N/A</b>		
			<b>N/A</b>		
			<b>N/A</b>		
			<b>N/A</b>		
			<b>N/A</b>		
			<b>N/A</b>		
			<b>N/A</b>		
			<b>N/A</b>		
Total Cost:		\$ 1850.00			
			<b>N/A</b>		
			<b>Yes</b>	Surface Condition? (G/P)	Good
