# Access Compliance Report

## Public Rights-of-Way

### (Curb Ramps)

| Intersection ID: 27349 | Main Street: DOVEHUNT_PL | Cross Street: MCALPINE_VALLEY_CT | Location: NE |

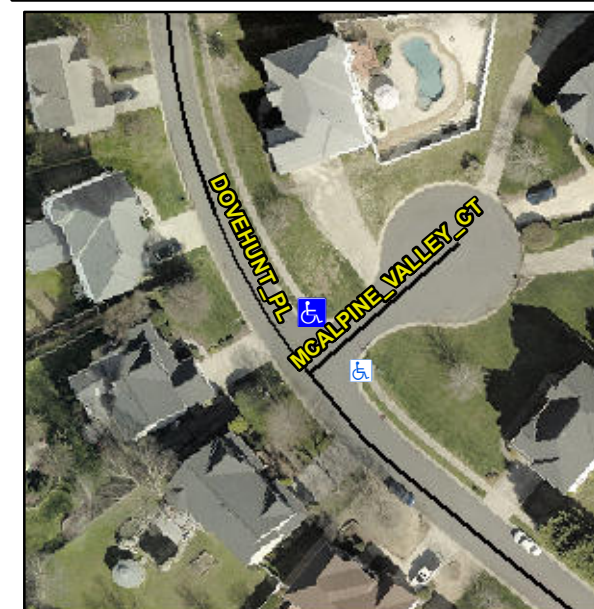
| ADA ID: 275FE9EB4B73 | Ramp Type: PerpDiag | Initial Pass/Fail: Fail | Overall Compliance: No |
| Severity Score: 67.5 | | | |

**Not Found, R304.5.1, R304.2.2, R304.5.3**

| Compliance | Description | Data | Compliance | Description | Data |
|---|---|---|---|---|---|
| N/A | Ramp Length (in) | 89.0 | No | Ramp Slope (%) | 13.7 |
| No | Ramp Width (in) | 33.0 | No | Ramp XSlope (%) | 10.4 |

**Remove & Replace Curb Ramp With Two New Directional Ramps or Equivalent.**

Total Cost: \$ 3200.00
