Access Compliance Report

Public Rights-of-Way

| Intersection ID: 51510 | Main Street: KENILWORTH_AV | Cross Street: PEARL_PARK_WY | Location: NW |
| ADA ID: 2797A456E6E5 | Ramp Type: Perp | Initial Pass/Fail: Fail | Overall Compliance: No |

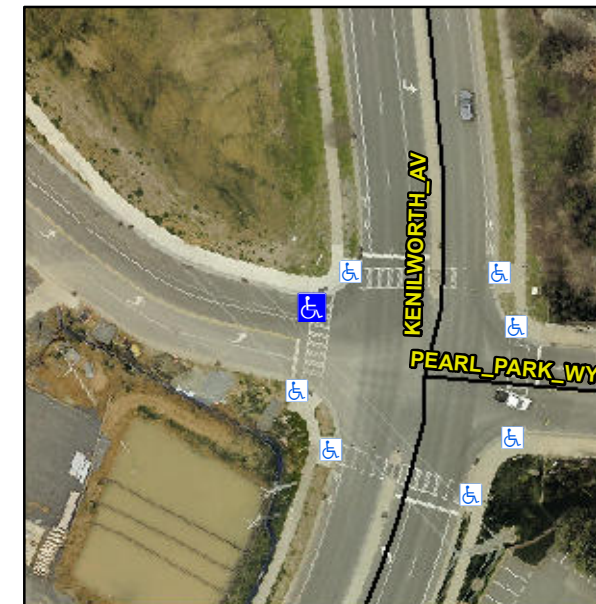
Not Found, R304.2.2, R304.5.3

| Compliance | Description | Data | Compliance | Description | Data |
|---|---|---|---|---|---|
| N/A | Ramp Length (in) | 93.0 | No | Ramp Slope (%) | 9.1 |
| Yes | Ramp Width (in) | 59.0 | No | Ramp XSlope (%) | 5.0 |

Remove & Replace Entire Ramp.
