Access Compliance Report

Public Rights-of-Way (Curb Ramps)

Intersection ID: 44293	Main Street: ANSEL_LN	Cross Street: ROCKWOOD_RD	Location: W
ADA ID: 279942AF07C3	Ramp Type: Perp	Initial Pass/Fail: Fail	Overall Compliance: No
			Severity Score: 21.25

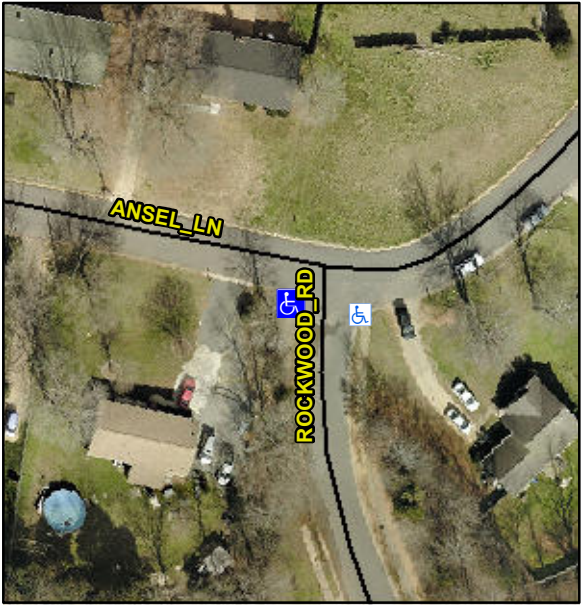
Possible Solutions:		Compliance	Description	Data
	Remove & Replace Entire Ramp.		Yes	Ramp Length (in)	55.5
			No	Ramp Width (in)	38.5
			N/A	Flare Type LT	N/A
			N/A	Flare Slope LT (%)	N/A
			N/A	Flare Traversable LT?	N/A
			N/A	Landing Length (in)	N/A
			N/A	Landing Width (in)	N/A
			N/A	Landing Slope (%)	N/A
			N/A	Landing X Slope (%)	N/A
<p>Surveyor Notes:</p> <p>N/A</p> <p>PROW/ADA:</p> <p>Not Found, R304.5.1, R304.5.3</p>			N/A	Flare Type RT	N/A
			N/A	Flare Slope RT (%)	N/A
			N/A	Flare Traversable RT?	N/A
			N/A	DWS Provided?	N/A
			N/A	DWS Contrast?	N/A
			N/A	DWS Length (in)	N/A
			N/A	DWS Full Width?	N/A
			N/A	DWS Offset (in)	N/A
			N/A	Gutter Ponding?	N/A
			N/A	Gutter Lip Ht (in)	N/A
			No	Painted X Walk1?	N/A
				X Walk 1 Direction	To SE
			N/A	X Walk 1 Width (in)	N/A
				X Walk 1 Slope (%)	3.0
				X Walk 1 X Slope (%)	1.1

N/A	Ramp inside XWalk1?	N/A
			N/A	Road Slope (%)	N/A
			N/A	Road X Slope (%)	N/A
			N/A	Any Obstructions?	N/A
				Obstruction Type	
Total Cost:					
					\$ 1850.00
			N/A	Clear Space?	N/A
			N/A	Clear Space to XWalk (in)	N/A
			N/A	Storm Grate/Utility Hazard?	N/A
				Storm Grate/Utility Type	
			N/A		N/A
			Yes	Surface Condition? (G/P)	Good
