Access Compliance Report

Public Rights-of-Way

(Curb Ramps)

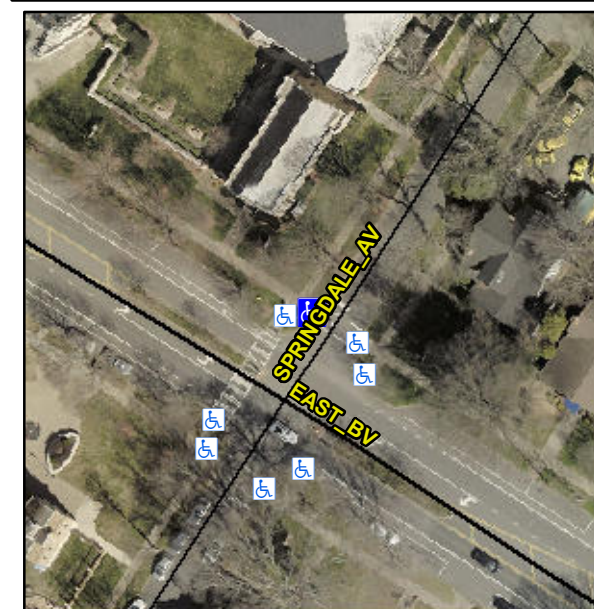
Intersection ID: 14547	Main Street: EAST_BV	Cross Street: SPRINGDALE_AV	Location: NE
ADA ID: 27AA467A725F	Ramp Type: Perp	Initial Pass/Fail: Fail	Overall Compliance: No
Codes/Mitigation Info/Possible Solution		Field Measurements/Component Compliance	
Severity Score: 13.75

Not Found, R304.2.2, R304.5.3

Compliance	Description	Data	Compliance	Description	Data
N/A	Ramp Length (in)	74.0	No	Ramp Slope (%)	9.7
Yes	Ramp Width (in)	72.0	No	Ramp XSlope (%)	3.5
N/A	Flare Type LT	N/A	N/A	Flare Type RT	N/A
N/A	Flare Slope LT (%)	N/A	N/A	Flare Slope RT (%)	N/A
N/A	Flare Traversable LT?	N/A	N/A	Flare Traversable RT?	N/A
N/A	Landing Length (in)	N/A	N/A	DWS Provided?	N/A
N/A	Landing Width (in)	N/A	N/A	DWS Contrast?	N/A
N/A	Landing Slope (%)	N/A	N/A	DWS Length (in)	N/A
N/A	Landing X Slope (%)	N/A	N/A	DWS Full Width?	N/A
N/A	Landing Curb? (Y/N)	N/A	N/A	DWS Offset (in)	N/A
N/A	Shared Landing?	N/A			
N/A	Gutter Ponding?	N/A	N/A	Gutter Slope (%)	N/A
N/A	Gutter Lip Ht (in)	N/A	N/A	Gutter X Slope (%)	N/A
N/A	Painted X Walk1?	Yes	N/A	Painted X Walk2?	N/A
	X Walk 1 Direction	To SE		X Walk 2 Direction	N/A
N/A	X Walk 1 Width (in)	110.0	N/A	X Walk 2 Width (in)	N/A
	X Walk 1 Slope (%)	2.1		X Walk 2 Slope (%)	N/A
	X Walk 1 X Slope (%)	1.3		X Walk 2 X Slope (%)	N/A

N/A	Ramp inside XWalk1?	Yes	N/A	Ramp inside XWalk2?	N/A
	Road Slope (%)	N/A	N/A	Clear Space?	N/A
	Road X Slope (%)	N/A	N/A	Clear Space to XWalk (in)	N/A
N/A	Any Obstructions?	N/A	N/A	Storm Grate/Utility Hazard?	N/A
	Obstruction Type			Storm Grate/Utility Type	
		N/A			N/A
		Yes		Surface Condition? (G/P)	Good

Possible Solutions:

Remove & Replace Entire Ramp.
