Access Compliance Report

Public Rights-of-Way

(Curb Ramps)

Intersection ID: 29683	Main Street: HUNTINGTON RIDGE CT	Cross Street: STAUNTON RD	Location: NW
ADA ID: 27C624576774	Ramp Type: PerpDiag	Initial Pass/Fail: Fail	Overall Compliance: No
Severity Score: 25			
Codes/Mitigation Info/Possible Solution		Field Measurements/Component Compliance

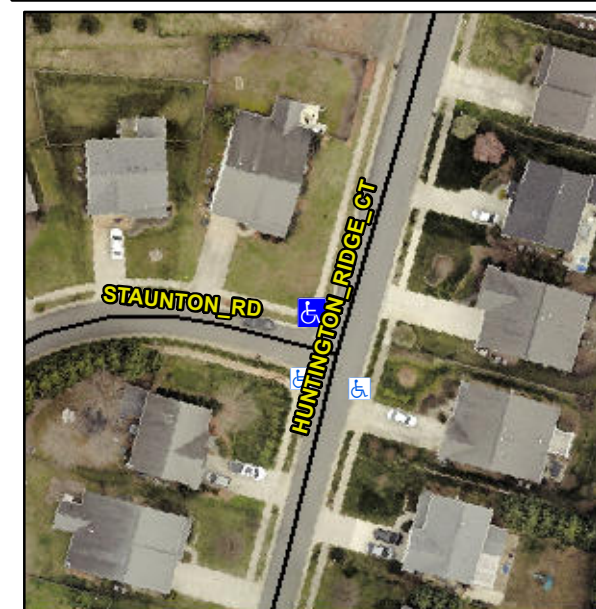
Not Found, R304.2.2, R304.5.3

Compliance	Description	Data	Compliance	Description	Data
N/A	Ramp Length (in)	49.0	No	Ramp Slope (%)	8.4
Yes	Ramp Width (in)	49.0	No	Ramp XSlope (%)	6.1
N/A	Flare Type LT	N/A	N/A	Flare Type RT	N/A
N/A	Flare Slope LT (%)	N/A	N/A	Flare Slope RT (%)	N/A
N/A	Flare Traversable LT?	N/A	N/A	Flare Traversable RT?	N/A
N/A	Landing Length (in)	N/A	N/A	DWS Provided?	N/A
N/A	Landing Width (in)	N/A	N/A	DWS Contrast?	N/A
N/A	Landing Slope (%)	N/A	N/A	DWS Length (in)	N/A
N/A	Landing X Slope (%)	N/A	N/A	DWS Full Width?	N/A
N/A	Landing Curb? (Y/N)	N/A	N/A	DWS Offset (in)	N/A
N/A	Shared Landing?	N/A			
N/A	Gutter Ponding?	N/A	N/A	Gutter Slope (%)	N/A
N/A	Gutter Lip Ht (in)	N/A	N/A	Gutter X Slope (%)	N/A
N/A	Painted X Walk1?	No	N/A	Painted X Walk2?	No
	X Walk 1 Direction	To S		X Walk 2 Direction	To E
N/A	X Walk 1 Width (in)	N/A	N/A	X Walk 2 Width (in)	N/A
	X Walk 1 Slope (%)	9.2		X Walk 2 Slope (%)	1.9
	X Walk 1 X Slope (%)	0.2		X Walk 2 X Slope (%)	9.4

N/A	Ramp inside XWalk1?	N/A	N/A	Ramp inside XWalk2?	N/A
	Road Slope (%)	3.5	N/A	Clear Space?	N/A
	Road X Slope (%)	8.0	N/A	Clear Space to XWalk (in)	N/A
N/A	Any Obstructions?	N/A	N/A	Storm Grate/Utility Hazard?	N/A
	Obstruction Type			Storm Grate/Utility Type	
		N/A			N/A
		Yes		Surface Condition? (G/P)	Good

Remove & Replace Curb Ramp With Two New Directional Ramps or Equivalent.
