Access Compliance Report Public Rights-of-Way (Curb Ramps)

Intersection ID: 30632Main Street: PROVIDENCE_RD_WESTCross Street: DIXIE_HILLS_DRLocation:SEADA ID: 27CCCF9566CARamp Type: BlendTrans1Initial Pass/Fail: FailOverall Compliance: NoSeverity Score:10

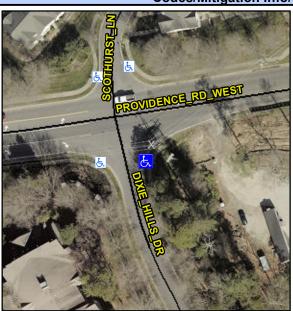
PROW/ADA:
Not Found, R304.5.1, R304.5.3

Field Measurements/Component Compliance					
Compliance Description		Data	Comp	liance Description	Data
N/A	Ramp Length (in)	44.0	Yes	BlendTrans Slope (%)	3.9
No	Ramp Width (in)	46.5	No	BlendTrans XSlope (%)	3.7
N/A	Flare Type LT	N/A	N/A	Flare Type RT	N/A
N/A	Flare Slope LT (%)	N/A	N/A	Flare Slope RT (%)	N/A
N/A	Flare Traversable LT?	N/A	N/A	Flare Traversable RT?	N/A
N/A	Landing Length (in)	N/A	N/A	DWS Provided?	N/A
N/A	Landing Width (in)	N/A	N/A	DWS Contrast?	N/A
N/A	Landing Slope (%)	N/A	N/A	DWS Length (in)	N/A
N/A	Landing X Slope (%)	N/A	N/A	DWS Full Width?	N/A
N/A	Landing Curb? (Y/N)	N/A	N/A	DWS Offset (in)	N/A
N/A	Shared Landing?	N/A			
N/A	Gutter Ponding?	N/A	N/A	Gutter Slope (%)	N/A
N/A	Gutter Lip Ht (in)	N/A	N/A	Gutter X Slope (%)	N/A
N/A	Painted X Walk1?	No	N/A	Painted X Walk2?	No
	X Walk 1 Direction	To N		X Walk 2 Direction	To W
	X Walk 1 Width (in)	N/A		X Walk 2 Width (in)	N/A
	X Walk 1 Slope (%)	3.7		X Walk 2 Slope (%)	3.1

X Walk 1 X Slope (%)	0.2		X Walk 2 X Slope (%)	4.0
N/A	Ramp inside XWalk1?	N/A	N/A	Ramp inside XWalk2?	N/A
	Road Slope (%)	3.7		Clear Space?	N/A
	Road X Slope (%)	2.5	N/A	Clear Space to XWalk (in)	N/A
N/A	Any Obstructions?	N/A	N/A	Storm Grate/Utility Hazard?	N/A
	Obstruction Type			Storm Grate/Utility Type	
		N/A			N/A
			Yes	Surface Condition? (G/P)	Good
				Curb Slope (%)	11.8

Remove & Replace Curb Ramp With
Two New Directional Ramps or
Equivalent.
